Northern House Inspections

Report: 2596 - Sample

Building Inspection Report

**38 Sample Street
Sample Town, VIC 3000**

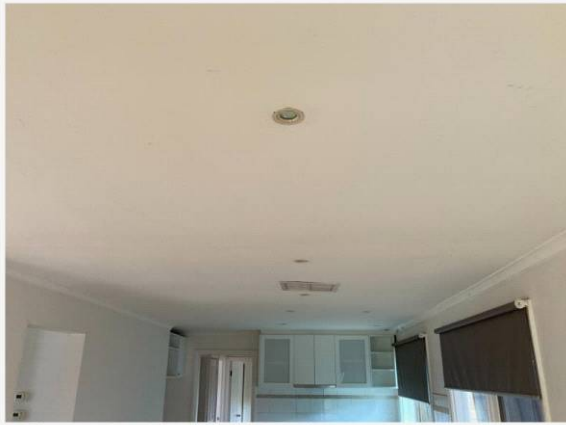
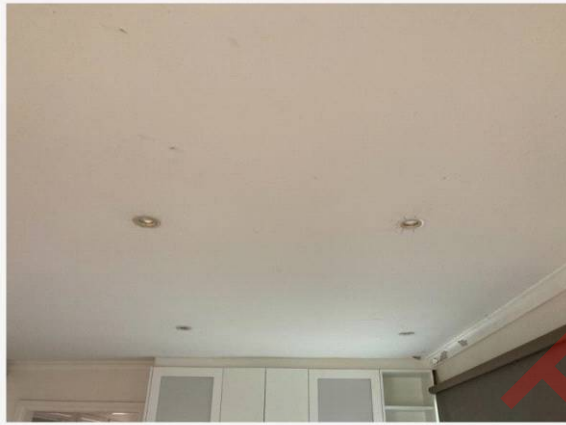
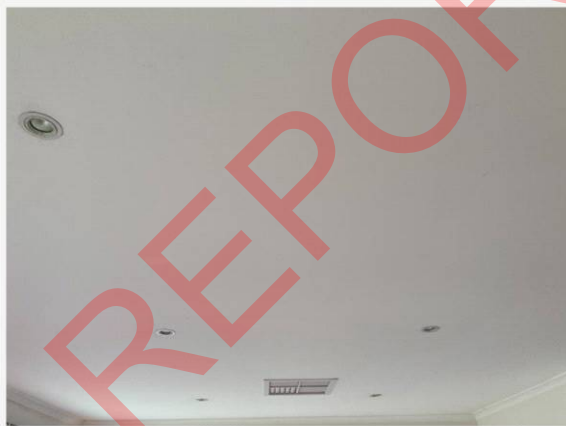
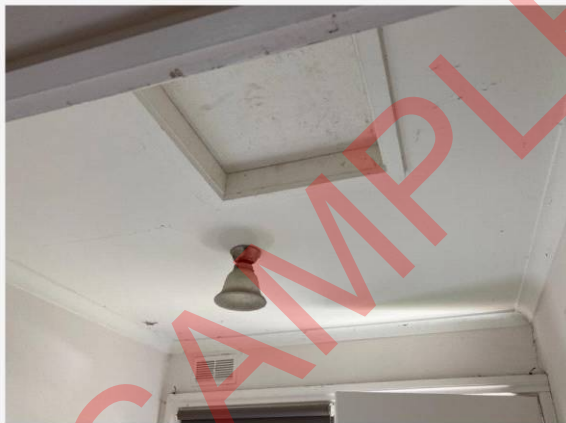
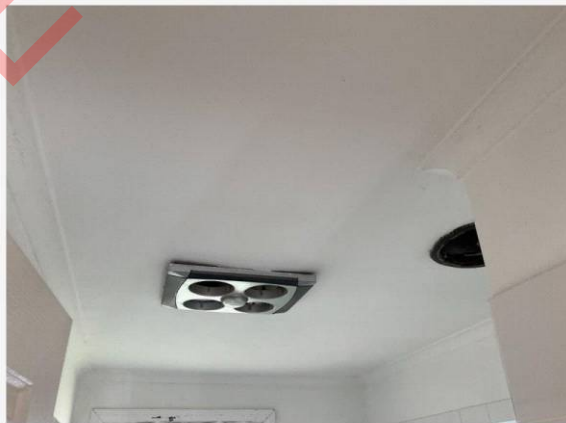
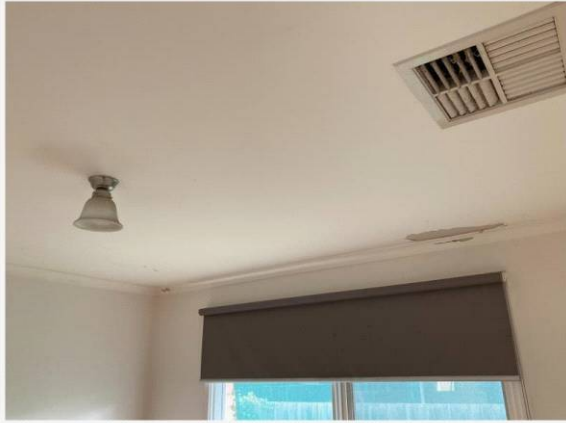
MAJOR DEFECT: Undulations and sagging / loss of adhesion was noted to ceiling linings throughout the dwelling in areas shown. This is the result of a loss of adhesion to ceiling joists or battens and a warning sign that the ceiling is under stress and may collapse. As the ceiling is vulnerable to collapse and poses a significant safety risk to occupants, this is considered a **major defect**. Immediate rework / replacement should be undertaken to sheeting where the fastening system has failed. A suitably qualified / licensed plasterer be called to make a further evaluation and repairs.

Note: Sagging / loss of adhesion / failure to ceiling linings can occur from excess moisture / condensation build up to installed plaster linings and / or settlement movement through the structure.

sagging/drop in ceiling noted example

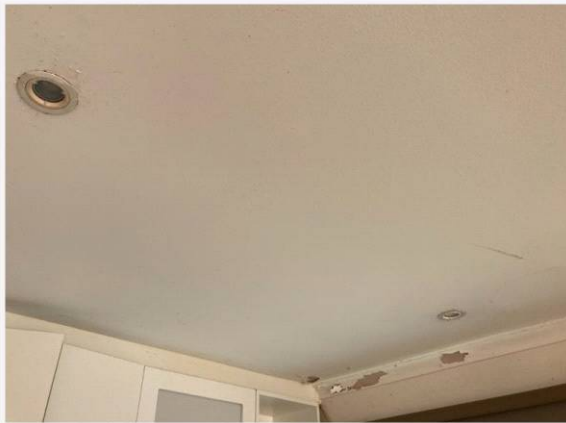
Evidence of moisture penetration / damage / paint peel to ceiling linings throughout the dwelling was also viewed. This is the result of cold spots on the ceiling that get damp from a condensation build up that occurs intermittently during the cooler months. Areas where moisture staining or paint peel is most noticeable is within wet areas,

moisture/condensation damage viewed

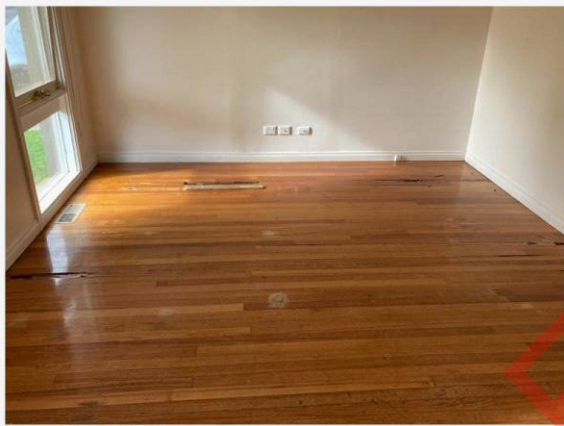
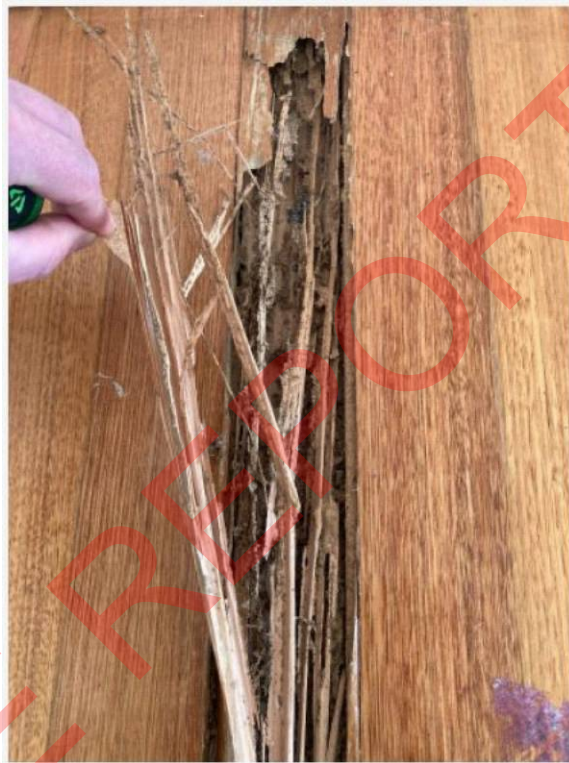
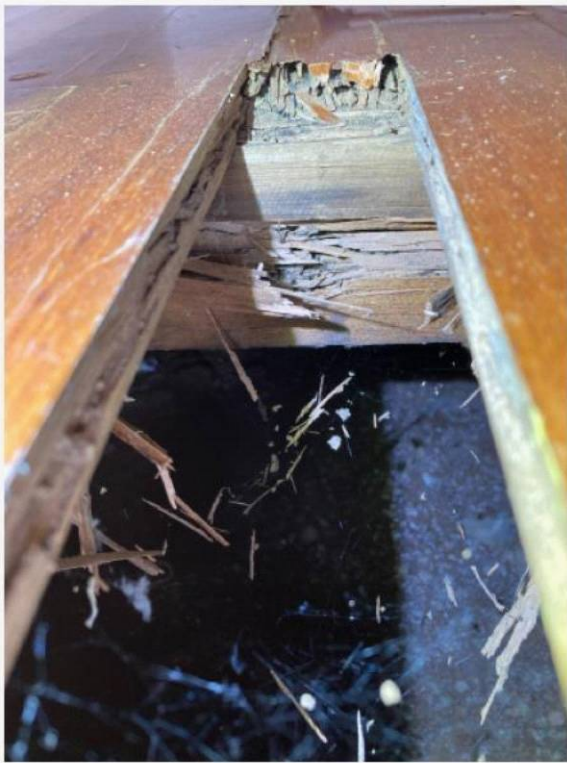
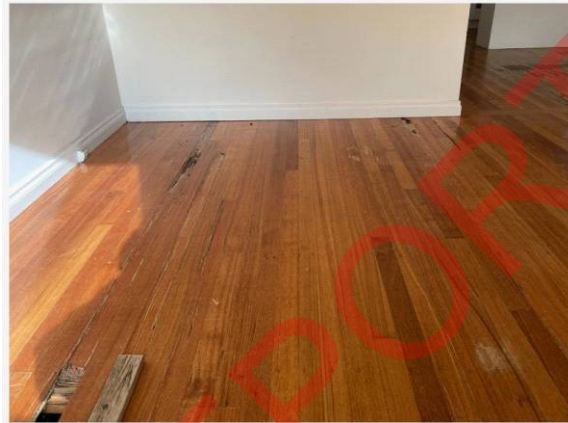
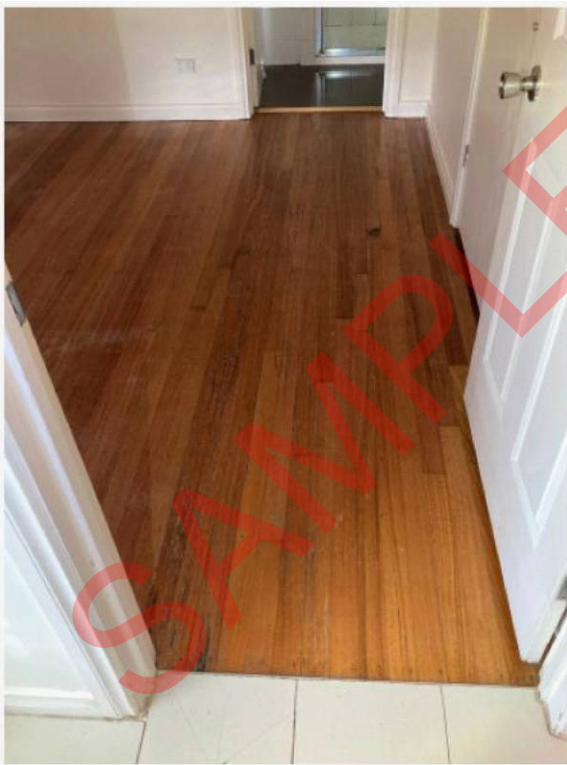
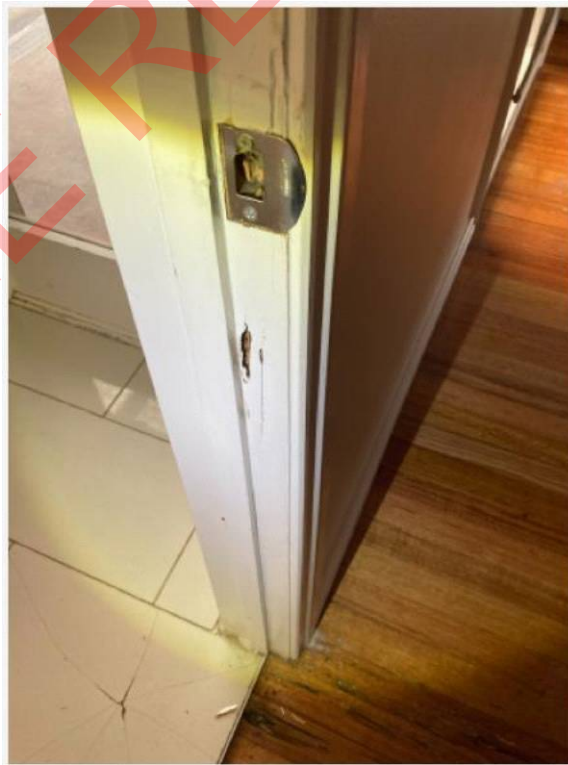
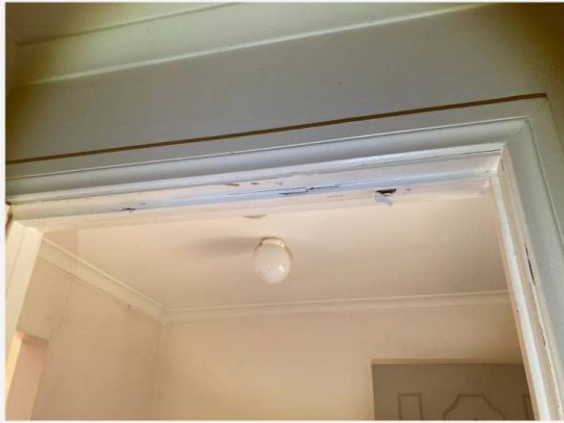
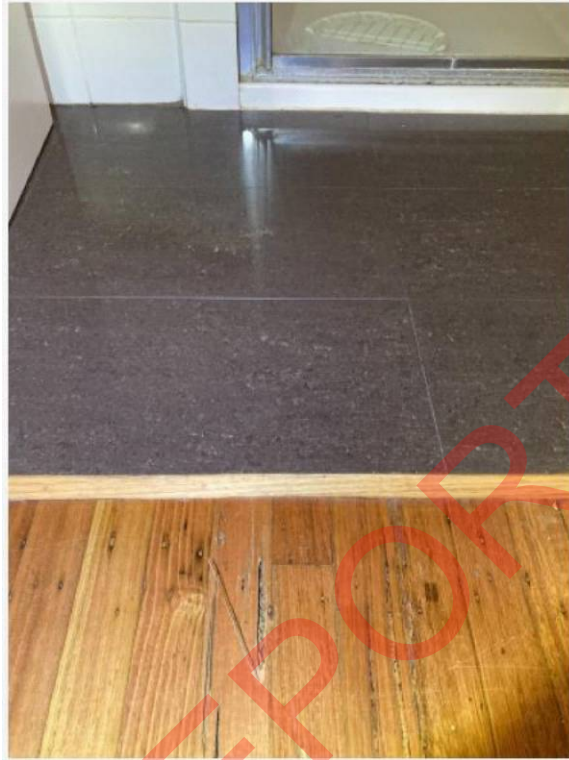
termite attack damage viewed to flooring

termite attack damage/workings viewed

termite attack damage viewed to joist

termite attack damage viewed to door jamb

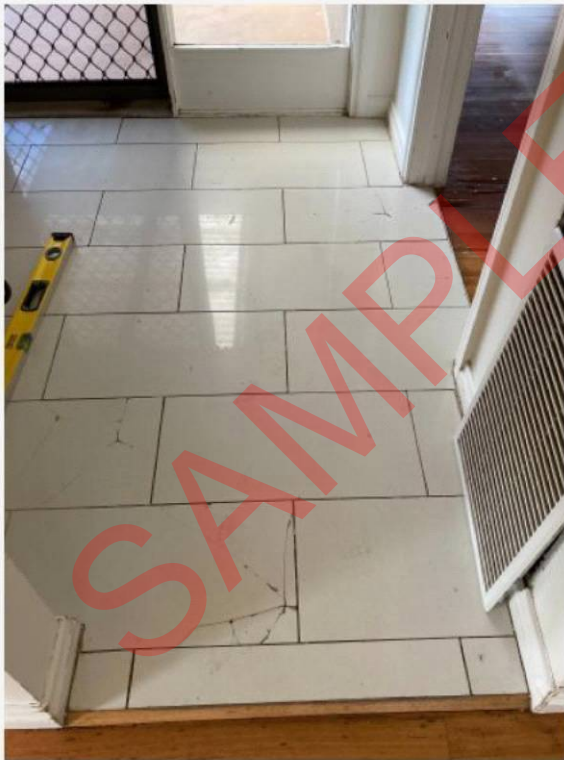
tile cracking from substrate damage

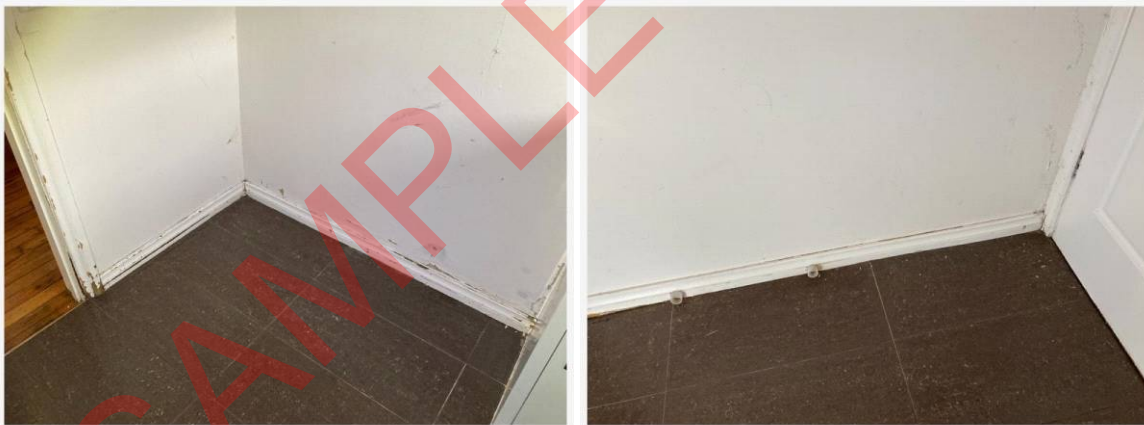
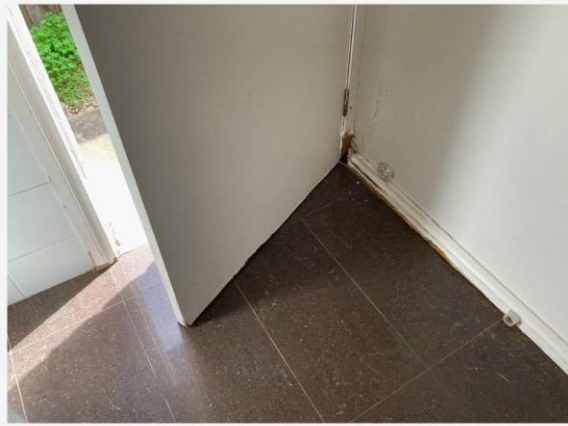
Water penetration has past tile grout / skirting board junctions and affected the flooring substrate materials. However, this damage appears superficial from within the subfloor. As such, in the opinion of the inspector, visible leak defects / damage is considered a **minor defect** to the buildings structure and it's elements.

moisture/water/leak damage viewed

We recommend the laundry area be allowed to dry out, affected materials should than be assessed, reworked / replaced and / or mould removed / treated as needed. Further investigation and rectification will be required and the scope of works should be determined by a licensed builder.

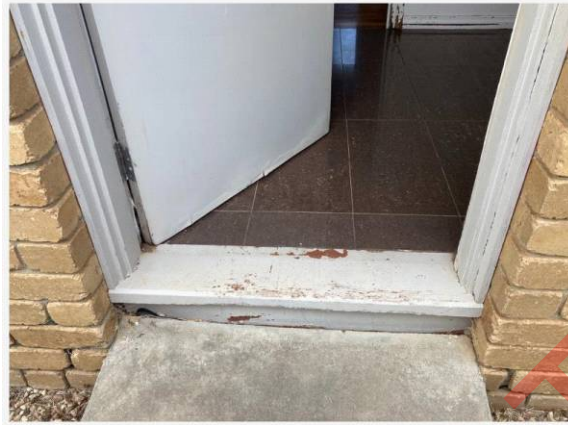
water entry/weathering through door likely

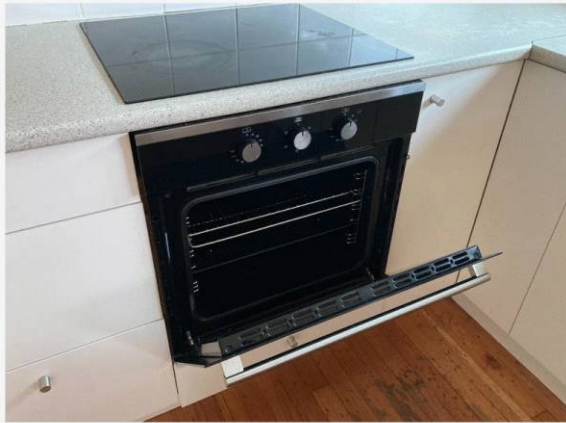
The condition of the cabinetry fixtures and appliances is generally good. However, the under bench oven is loose / not secured to the surrounding cabinet. We recommend additional screw fixings through the flange to the face of the cabinet. The installed dishwasher is not connected. A licensed plumber should be called to make further evaluation and repairs as needed.

secure oven to cabinet

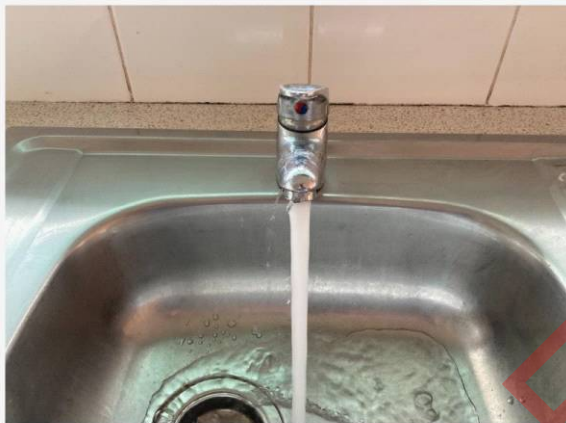
The mixer tap is loose or has faulty mount / washer fixings. This will require maintenance repairs and a licensed plumber should be called to make further evaluation and repairs as needed.

mixer mount / washer loose

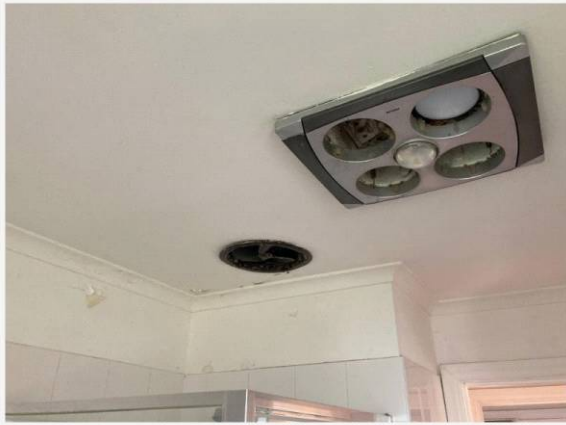
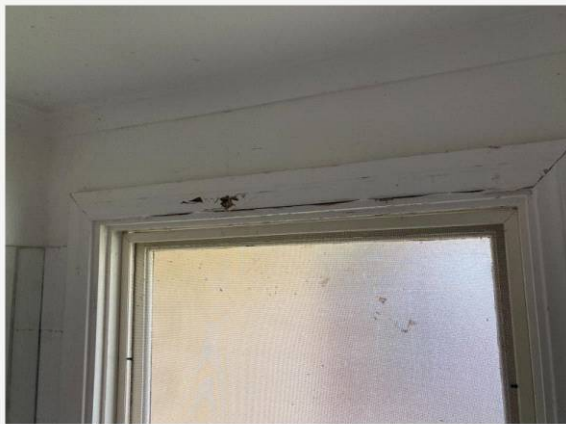
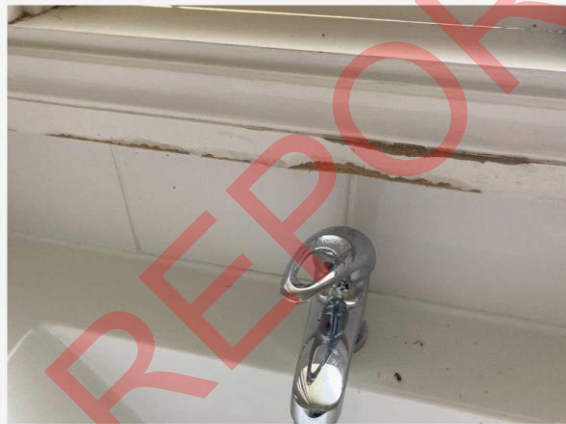
Evidence of moisture damage / paint peel to ceiling / wall linings and window trims was viewed. We suspect a lack or use of ventilation provisions as the cause.

moisture damage viewed

water splash damage to MDF trim

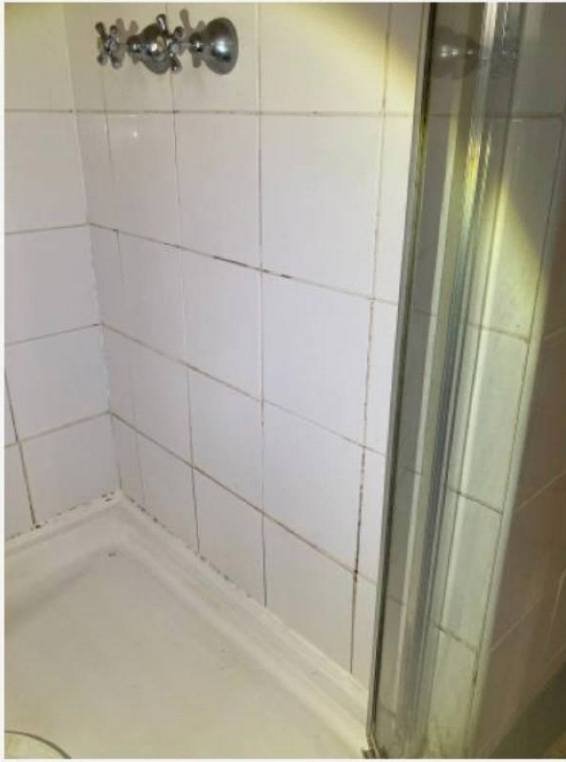
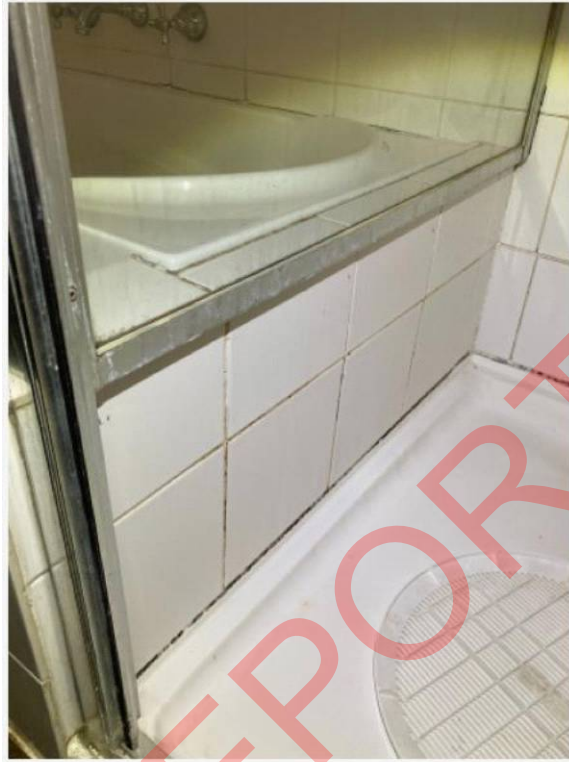
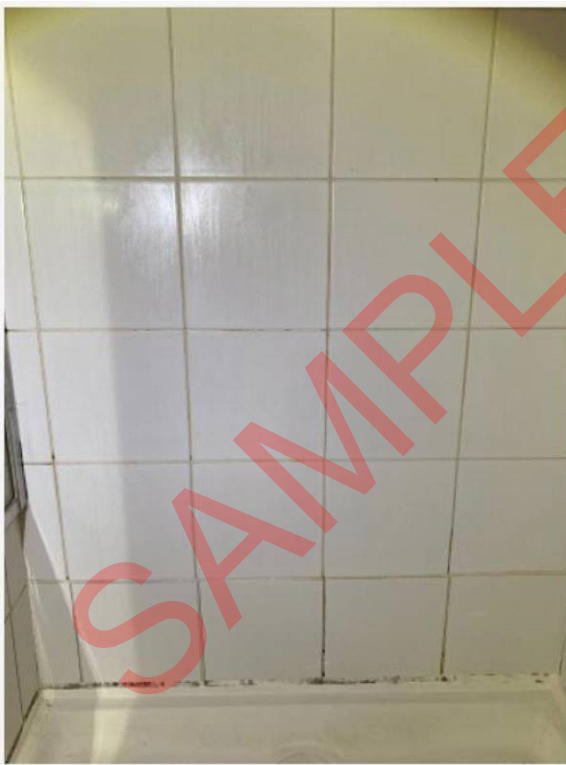
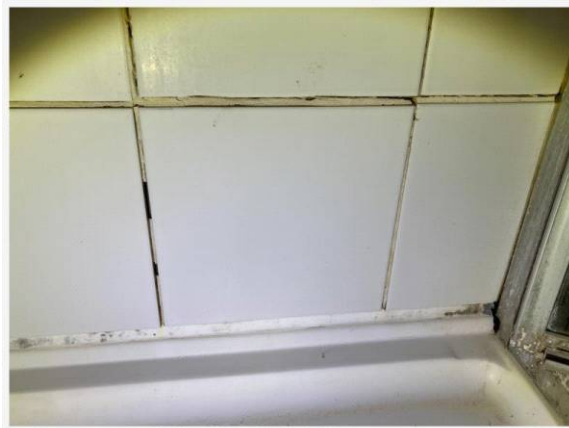
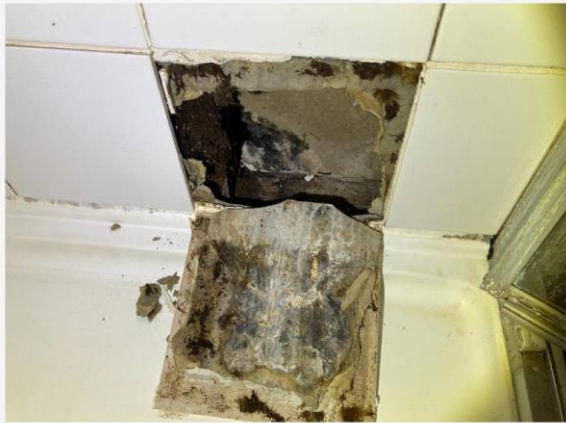
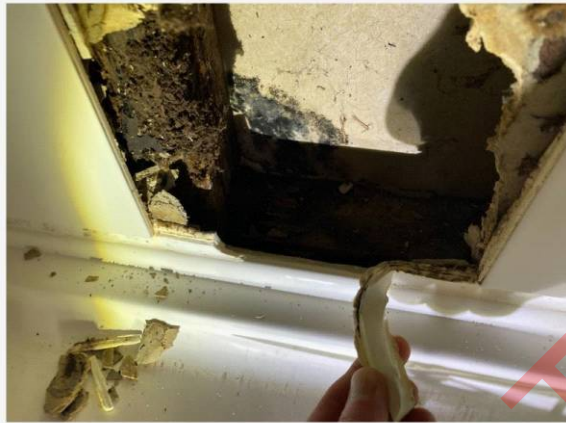
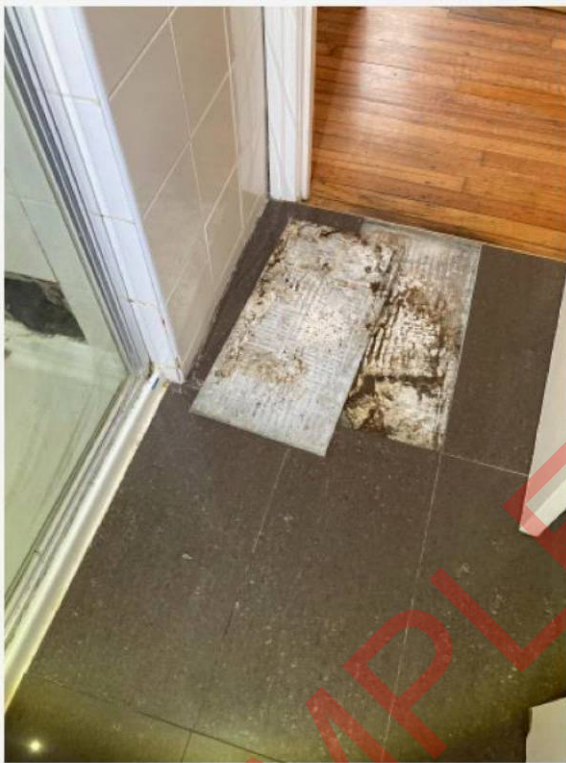
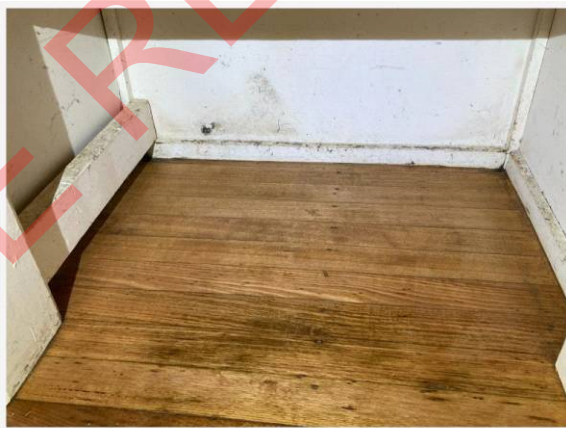
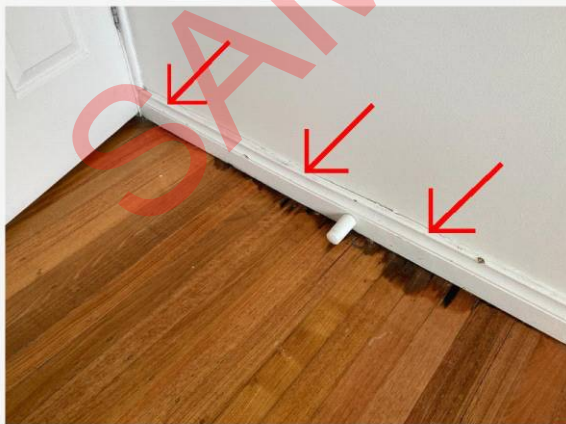
MAJOR DEFECT: High / elevated moisture was detected within the shower recess and visible leak damage to outside areas of the shower was noted. Significant shower leak damage and wet rot decay to subfloor timbers was also viewed. **See (SUBFLOOR) for further findings.**

Present high moisture and visible moisture damaged / swollen / blistered surrounding materials are visible signs of active / sustained shower leak defects. This evidence suggests a total failure of waterproofing provisions from the substandard methods of construction detail noted. Furthermore, this significant shower leak defect is the likely cause / leading conducive condition of the noted termite attack to the property. As such, in the opinion of the inspector this is considered a **major defect** to the building and its elements.

IMPORTANT NOTE: The root cause and full extent of leak damage to surrounding areas cannot be fully assessed without a more invasive inspection.

waterproofing defects visible

poor construction methods noted

water breach noted

substrate not installed over tray flange

water spread / breach noted

We recommend a full rework of the shower recess and its waterproofing detail will be required. Further assessment, a scope of works and rectification should be determined by a licensed builder within the immediate term.

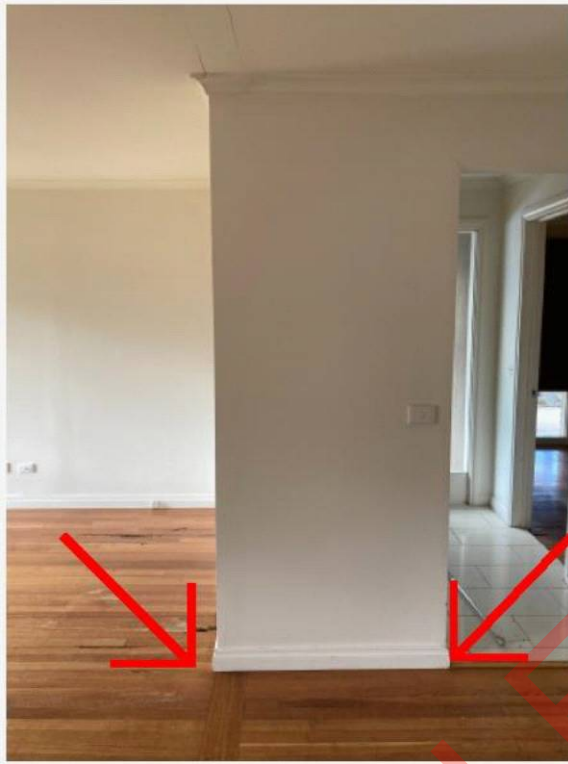
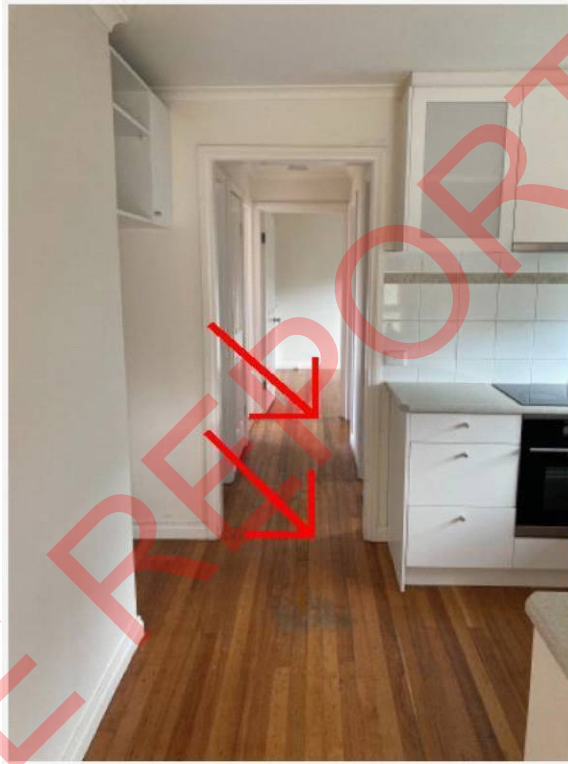
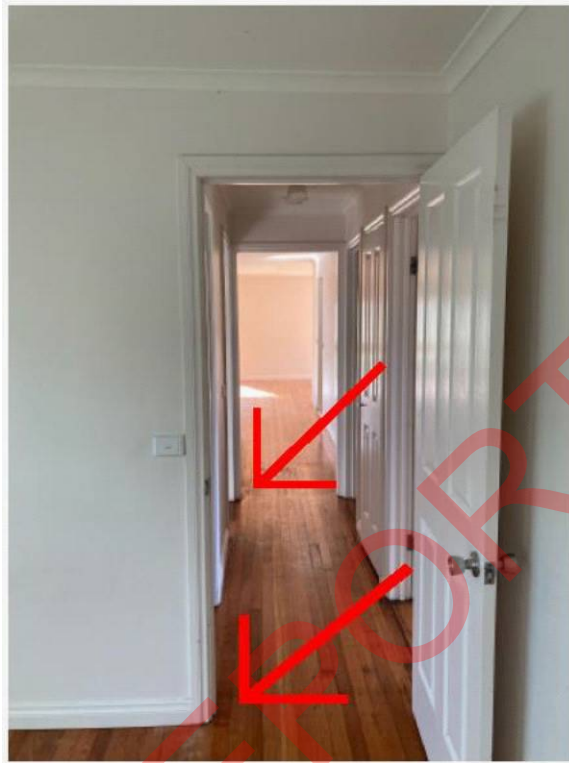
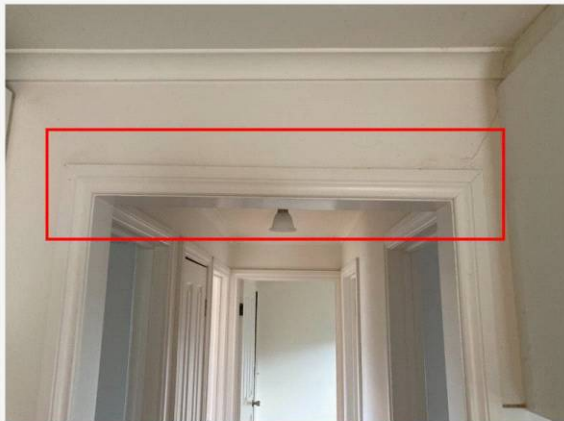
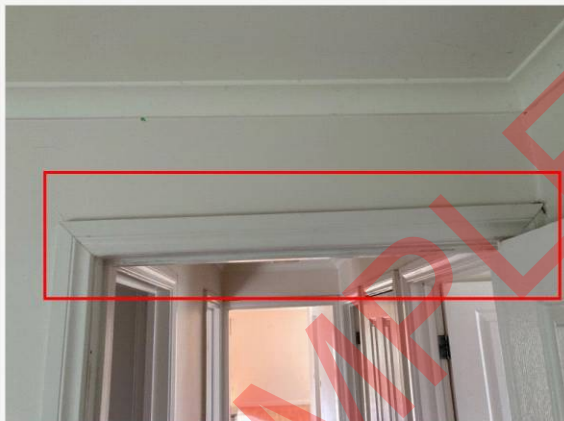
As stated above, we did note uneven floor framing that in turn, has transferred through wall framing that has caused visible settlement cracking to walls and out of square door frames / jambs within various sections of the dwelling as shown.

concrete stumps shows evidence of localised consolidation / differential settlement of the underlying foundations and a measured drop / settlement of stump footings below internal load bearing walls has occurred.

From observations on the day, this movement has / had occurred as a result of one or the combination of common factors including; normal cyclic saturation and drying out of underlying foundation soils of the site, the age and location of the dwelling (Melton is located in reactive clay type soils), the presumed shallow / narrow / brittle nature of constructed footings below the dwelling.

Note: Differential settlement in a house of this age and construction type is common and usually due to ground movement of reactive soils as moisture levels change beyond equilibrium / the design limits of the footing system constructed. The subsequent movement to building materials can be expected. We observed no evidence of major structural defects or significant safety issues to the super structure on the day. However, we cannot be definitive in that foundation and stump footings below the dwelling are or will remain stable long term. The expected rework outcome of this issue is unknown until further information / monitoring is obtained.

differential settlement/deviations noted

frame/jamb out of square

Rework options / outcomes: Affected areas should be monitored for a period of 18 - 24 months to establish a time line of structural stability. Visual clues of ongoing building movement will be more evident if wall cracking near window / door / room openings is observed. Options to rectify floor levels if needed or desired may include; some re-stumping at proper founding depth to assist in load distribution, the re-packing / levelling of subfloor framing below affected areas, increasing the number of stump footings / supports and associated subfloor framing below high building load areas to create continuous spans and assist in load distribution. (Note: damage to internal components / materials should be accounted for with these options). We recommend a licensed builder be engaged to comment upon and offer higher level advice regarding the above issues as needed.

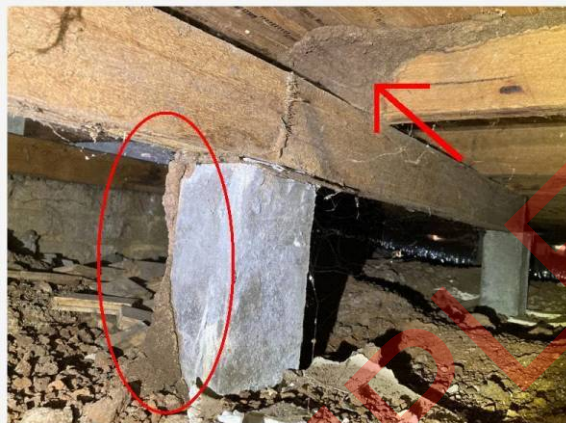
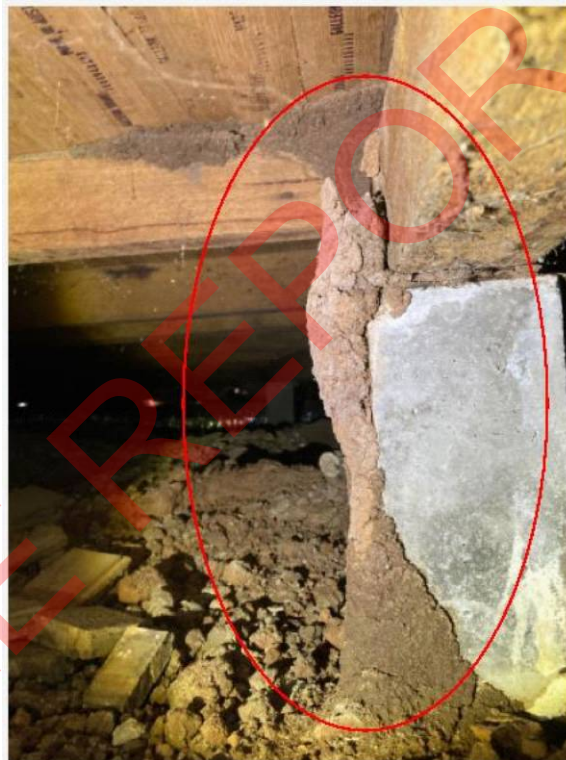
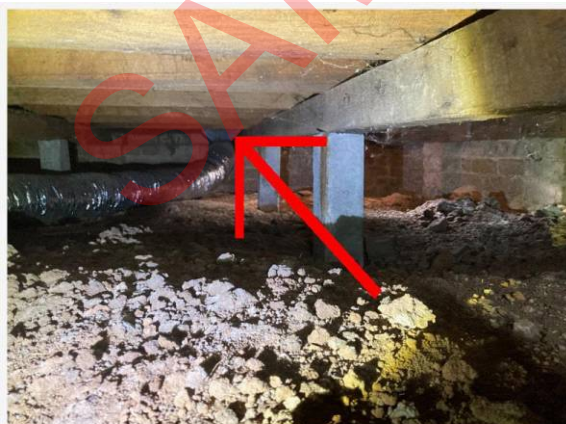
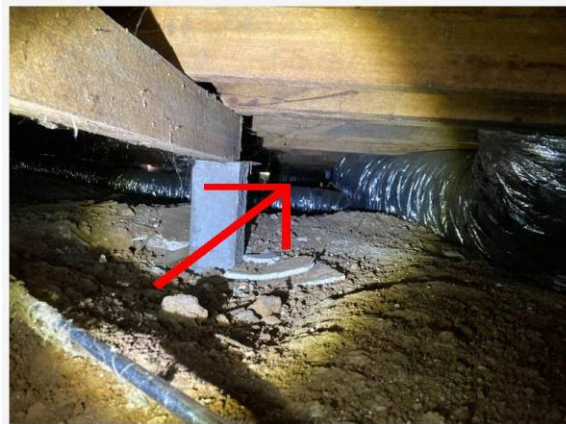
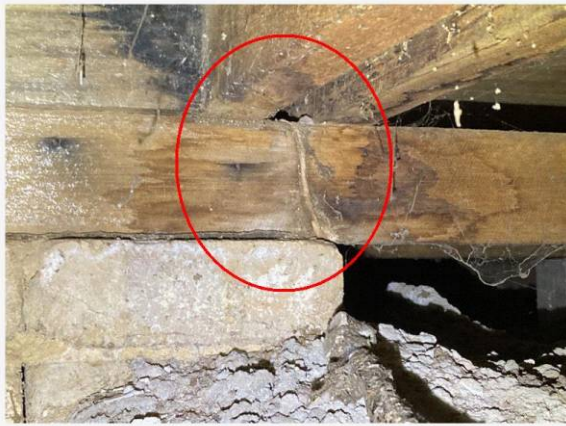
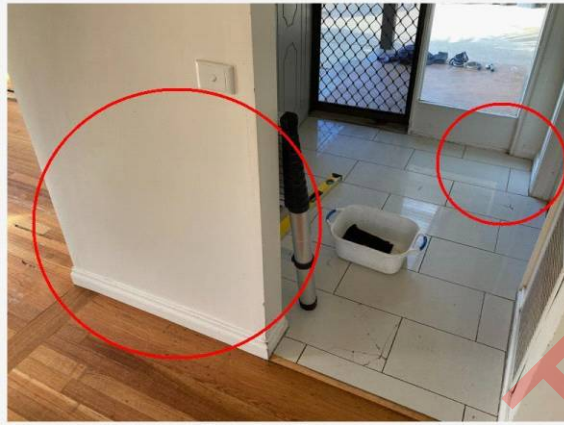
There is damage consistent with timber pest (termite) attack to visible accessible flooring timbers below the lounge, entry and main bedroom area. Due to noted timber pest attack some timber replacement (floorboards and subfloor framing) will be required. The full extent of timber replacement and/or repair can not necessarily be determined during this visual inspection and a more invasive assessment will be required. A licensed builder should be called to make a further evaluation and repairs or rectification as needed.

termite mud lead noted below entry/lounge

termite attack damage through lounge

termite attack damage toward bathroom

termite mud lead noted below entry

areas of termite attack entry noted below

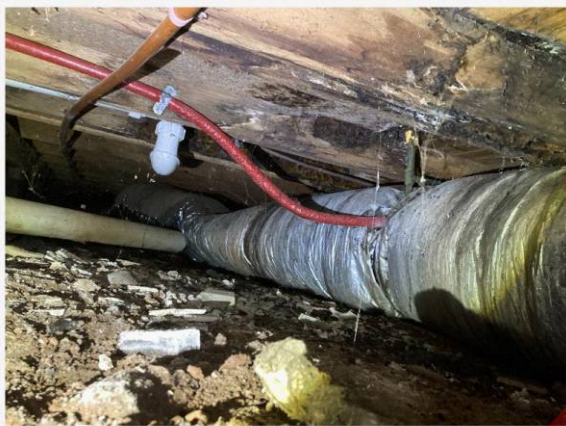
Significant wet rot / fungal decay and staining damage was noted to flooring and floor framing below the bathroom. Moderate decay damage was noted but not limited to the floorboards, floor joists and bearers below this area. The extent of the visible damage has been categorised as a **major defect** to the building element(s). A licensed builder should be called to make a further evaluation and repairs or rectification as needed.

significant shower leak defects noted

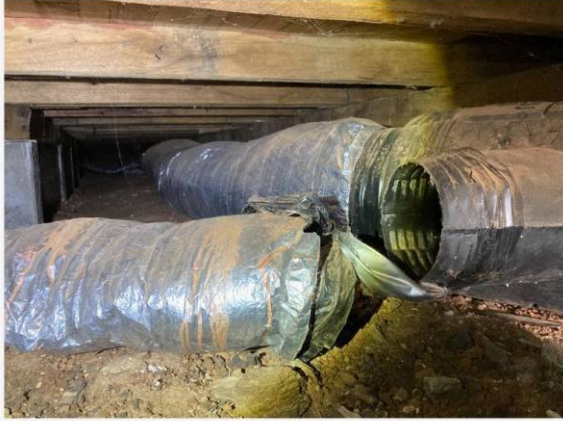
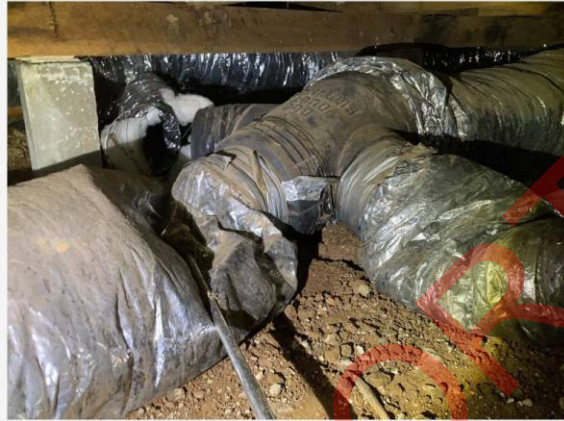
Ducting associated with heating is disconnected from various 'BTO' branch connectors or is squashed from subfloor access as shown. A licensed HVAC plumber should be called to make a further evaluation and repairs or rectification as needed.

duct disconnected| re-tape

duct squashed| replace affected section

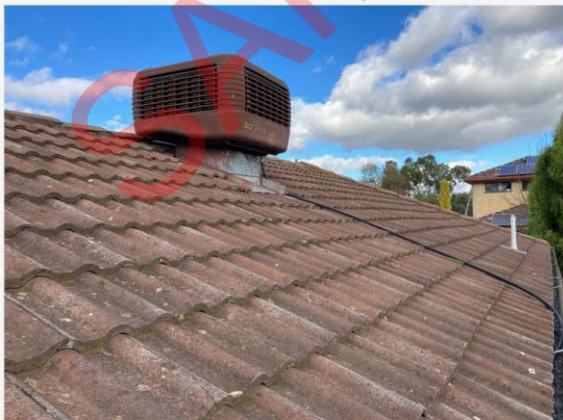
The overall condition of the roof coverings is fair. Mortar bedding / pointing to hip and ridge cappings is cracked / loose / missing and will require re-bedding and pointing within the short term. It also appears roof tile coatings have deteriorated and are approaching the end of their weatherproofing service. We advise that roofing will require pressure cleaning, priming and sealing within the short to medium term. Maintenance is recommended to prevent potential water ingress into the building and extend the service life of roofing materials. A qualified roof restoration contractor should be called to make a further evaluation and repairs or rectification as needed.

clean,prime,repaint & seal roofing

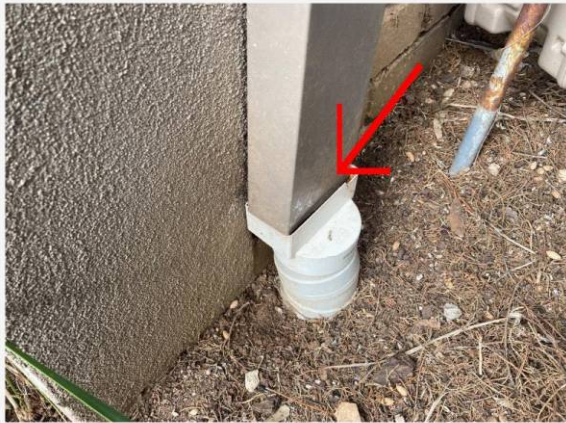
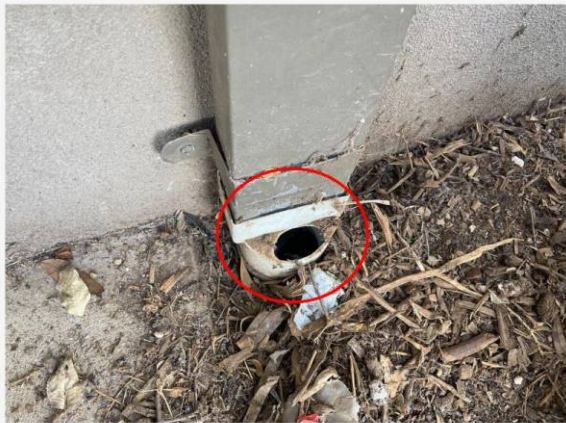
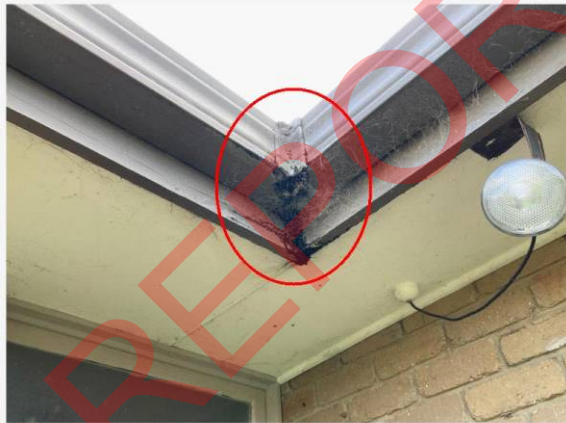
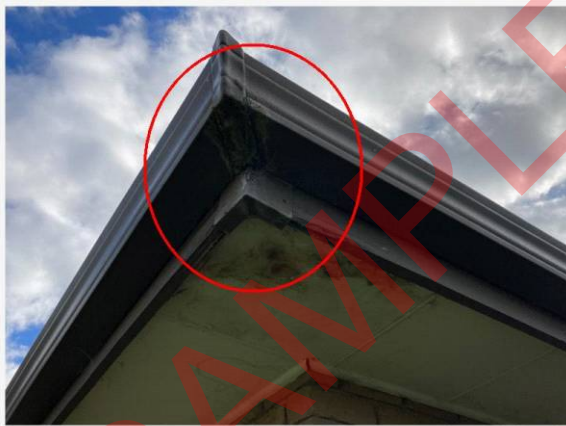
Leaf / organic debris is present in and / or blocking gutters and downpipes of the dwelling. These should be cleared to prolong the life of the guttering material and prevent any stormwater blockage and subsequent water overflow / ingress to the dwelling. Ongoing maintenance, cutting back of tree limbs over roof areas and / or some form of gutter guard is suggested.

A licensed roof plumber should be called to make a further evaluation and repairs or rectification as needed.

rework DP into adaptor

rework/secure DP to gutter pop

replace broken PVC adaptor

repair joints/replace bracket

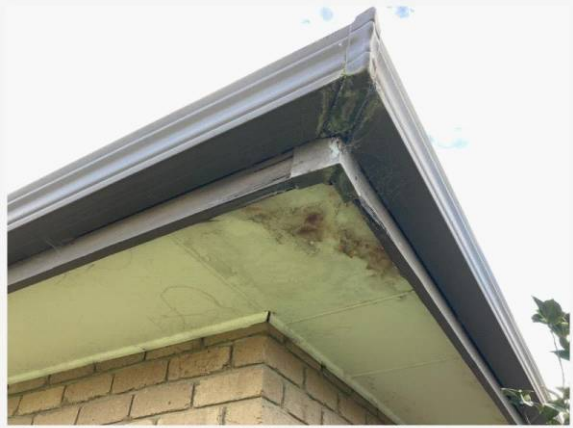
Water damage/staining is present to the eaves linings to the rear - left which is due to gutter joint leaks and / or gutter overflow. This should be further evaluated by a roofing contractor.

leak staining/damage noted to eaves

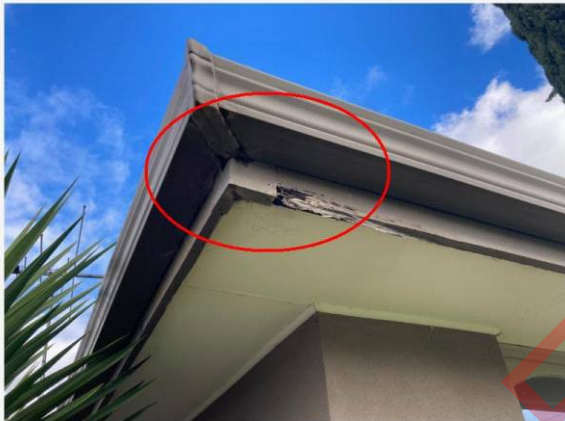
Wet rot decay and paint peel is present to fascia timbers around the dwelling and maintenance is required. A licensed carpenter and painter should be called to make a further evaluation and repairs or rectification as needed.

gutter leak causing timber decay example

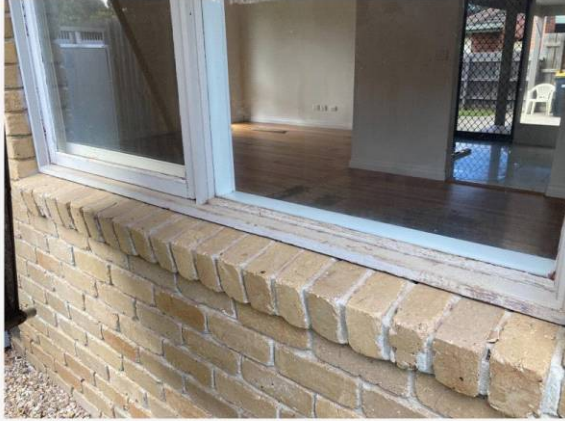
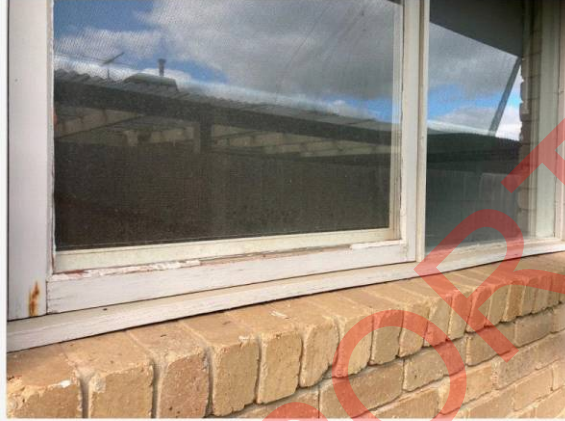
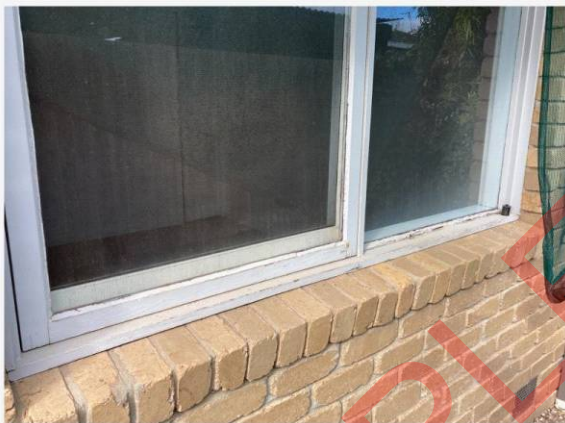
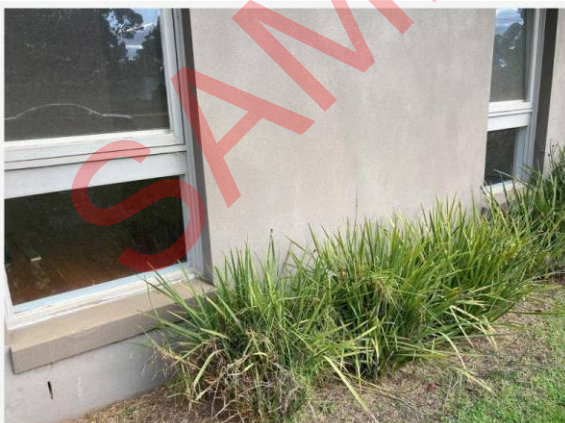
Paint peel and weathering along with minor wet rot decay is present to window frames as shown. Maintenance will be required and a licensed carpenter and painter should be called to make a further evaluation and repairs or rectification as needed.

weathering/paint peel/minor decay noted

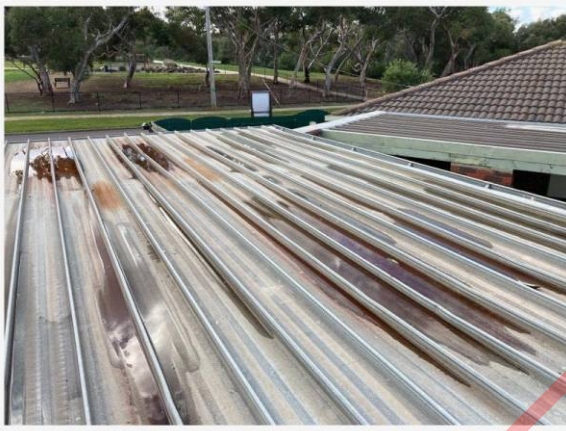
The metal roofing is rusting and requires treatment to limit further deterioration.

standing water causing rust decay

A licensed roof plumber should be called to make a further evaluation and repairs or rectification as needed.

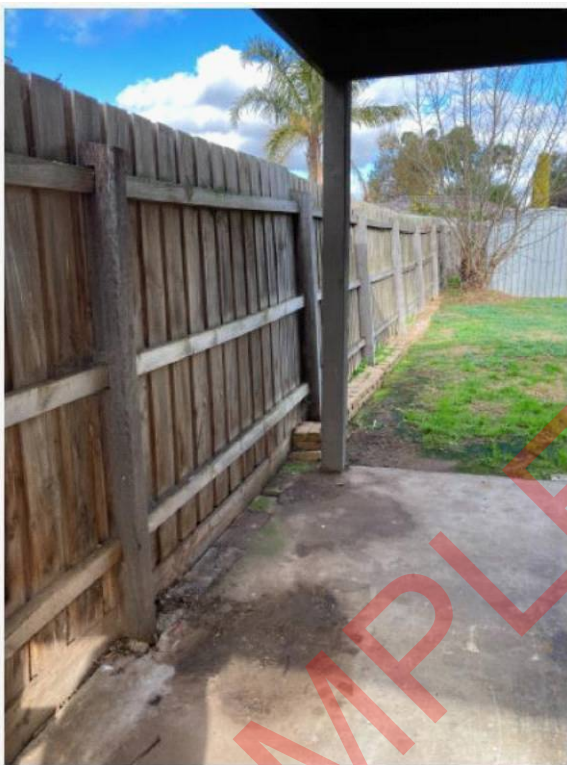
The left boundary timber fence is leaning but, appears stable in its current position. Repairs may be considered as needed. A licensed carpenter or fencer should be called to make a further evaluation and repairs or rectification as needed.

LHS fence leaning but stable| minor decay

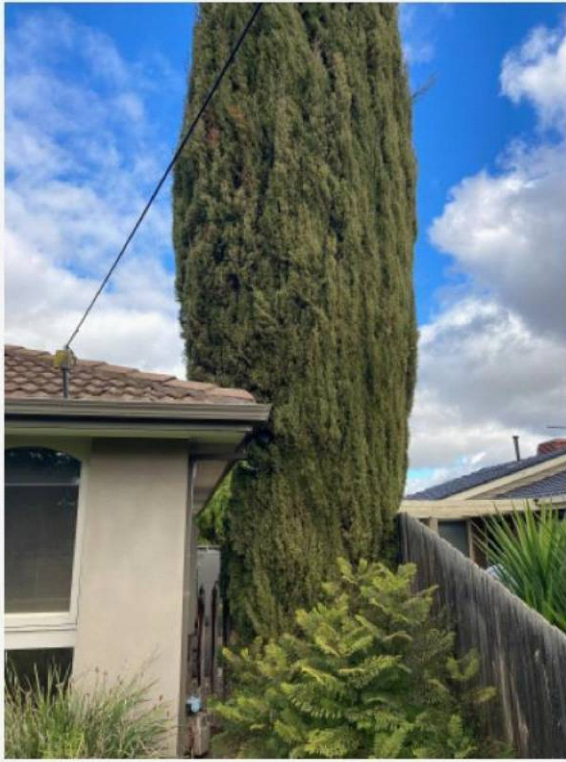
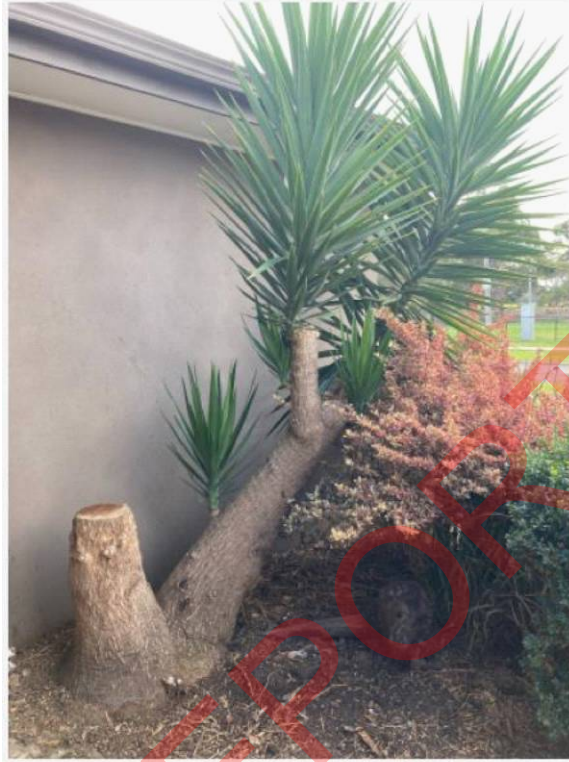
Trees and their root systems are located close to the buildings footings with tree limbs over the roof area and we recommend the removal of offending trees and/or vegetation and undertake repairs if necessary.

recommend tree removal

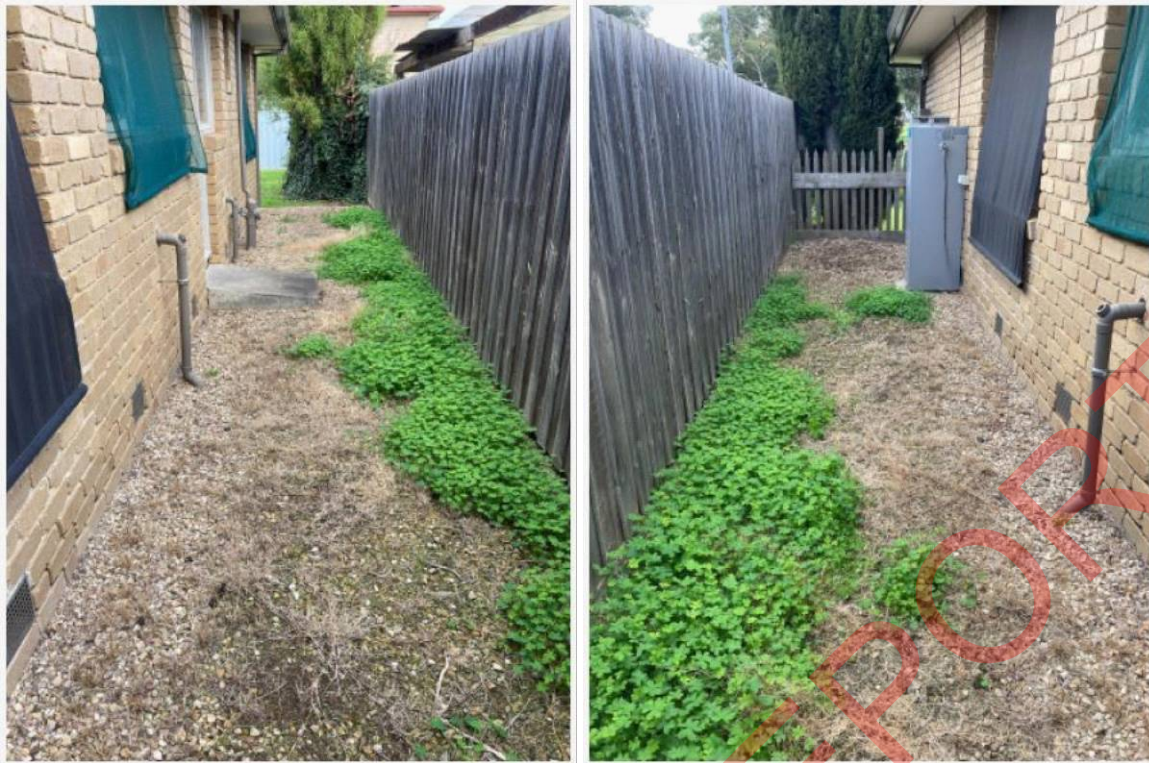
Drainage provisions and ground grading / falls from / along the right side and rear are inadequate / or suspect. As a result, surface water and runoff may pond and / or be directed toward the house. Poor site drainage can create unstable foundations that may have an adverse structural affect over time and may produce conditions conducive to termite attack. Spoon / agi drains should be installed or concrete / paved paths be constructed and graded to divert seepage and surface runoff water away from the house. The drains should be connected to the existing stormwater drainage system. We recommend the site be monitored during heavy rain to determine rework options, additional drain provisions and ground works that will be required. Please contact a licensed drainage plumber or landscaper for further information.

poor ground grading & drainage identified
