Northern House Inspections

Report: 2596 - Sample

Building Inspection Report

**38 Sample Street
Sample Town, VIC 3000**

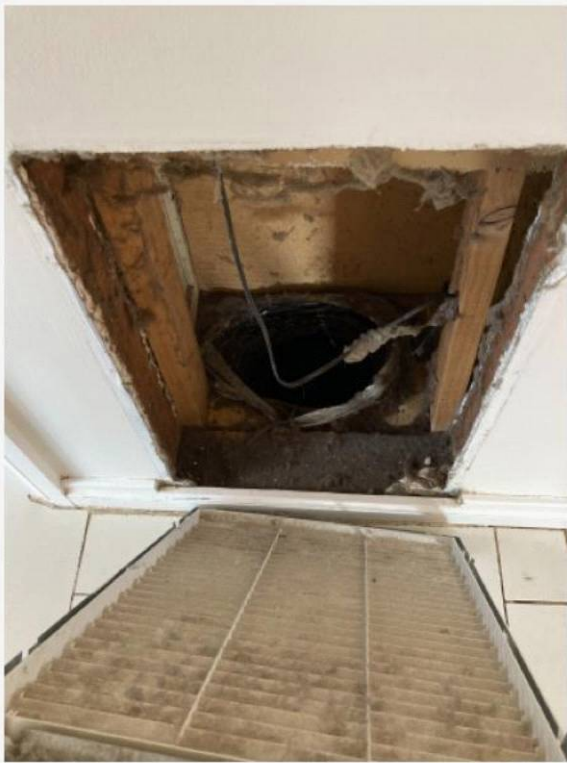
We have noted that no return air filter has been provided to the grille in the entry area. A licensed HVAC plumber should be contacted to install a filtered grille.

recommend filter to return grille

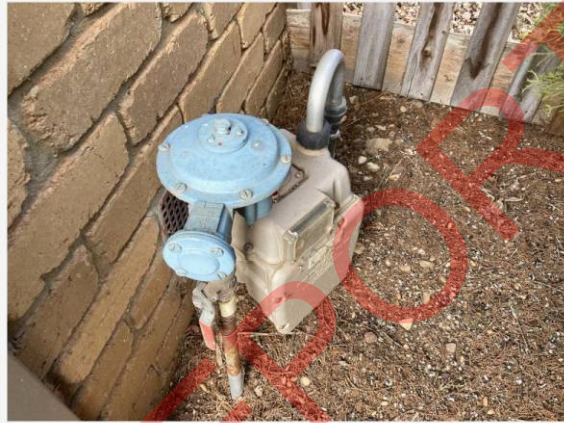
Gas / rotten egg smell emanated from the gas meter on the day. This suggests a gas leak may be present. A licensed gas plumber should assess and make good.

gas smell noted | have meter assessed

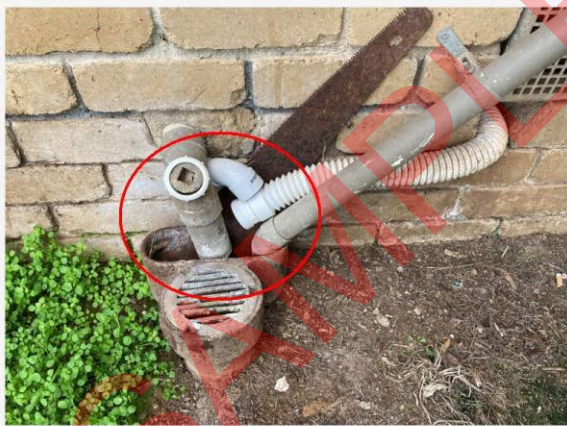
We did note poor waste plumbing connections, / diversions into the cast iron tundish. A licensed plumber should be called to make a further evaluation and repairs or rectification as needed.

rework/seal waste lines into tundish
