Northern House Inspections

Special Purpose Inspection Report

Narre Warren North, VIC 3804

May 20, 2020

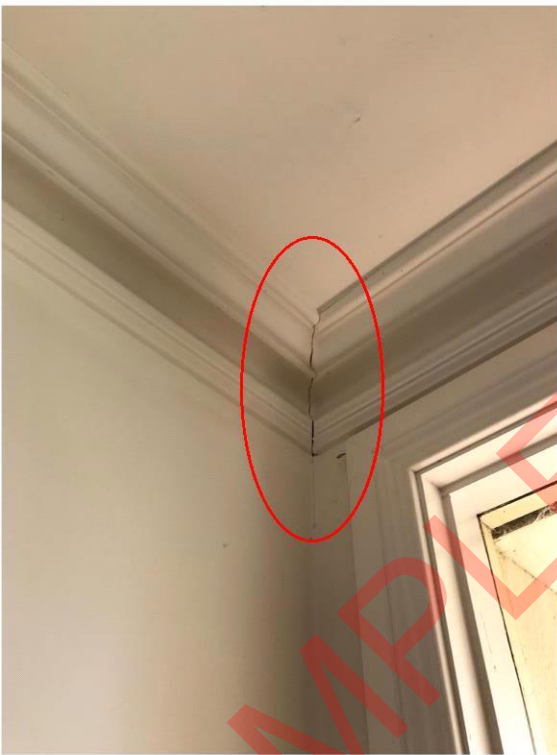
MINOR STRUCTURAL DEFECT: Slight settlement cracking was viewed / assessed to cornices within the entry and main bedroom areas as shown. Noted cracking appears to be the result of localised slab movement within these areas. **See (Walls) for further findings and information.** Recommend cracks be monitored for further movement over a period of time (12 months) to establish foundation stability. If cracking continues to increase or becomes wide spread, this should be referred to a structural engineer for further comment and advice regarding rectification.

settlement cracking viewed (entry)

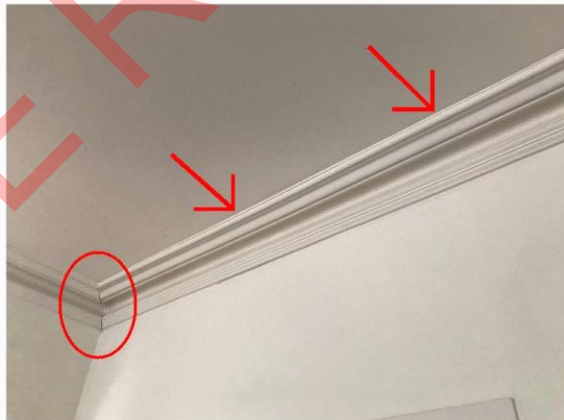
settlement cracking viewed (main bed)

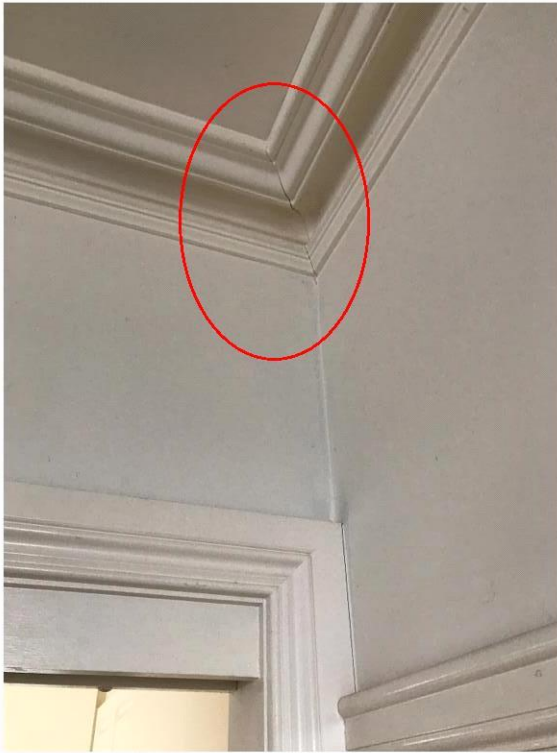
Slight settlement cracks were noted to areas within the front hallway and kitchen as shown. As there is no additional damage or distortion to surrounding components, noted cracking appears to be a result of normal building settlement and / or cyclic movement. Other likely cause may include vibration damage from the hall sliding door and heat stress from wall oven use. Periodic maintenance may be required by a suitably qualified plasterer.

minor settlement cracking viewed (hall)

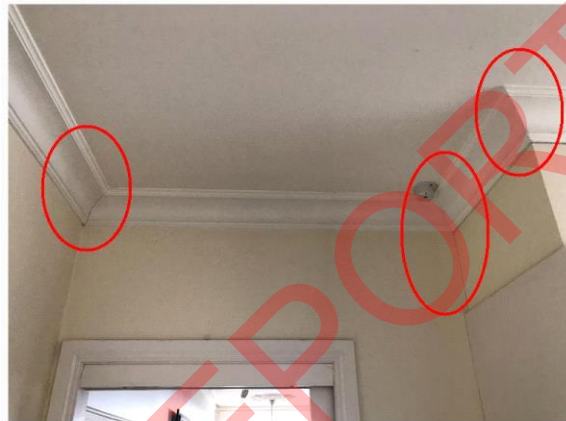
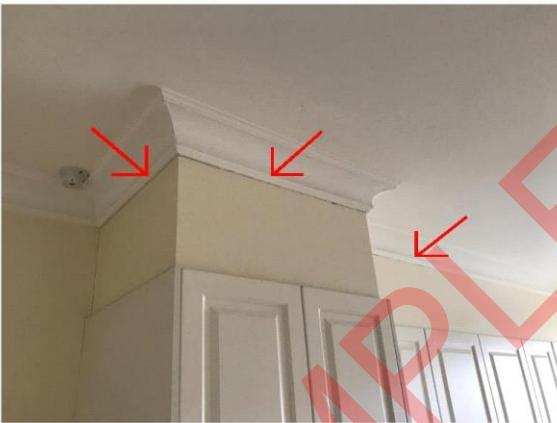
minor settlement cracking viewed (kitchen)

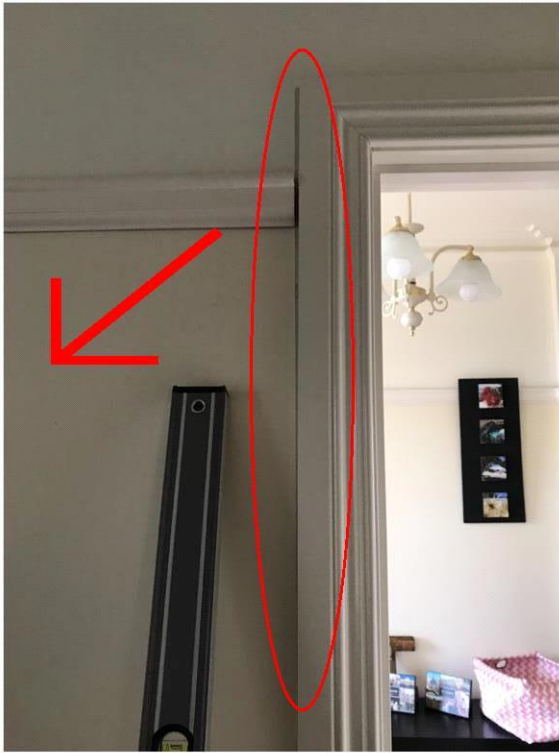
MINOR STRUCTURAL DEFECT: Separation / movement cracking is evident to the main bedrooms north wall lining as shown. Noted movement defect in the opinion of the inspector, is due to slab footing movement / subsidence. As the separation cracking is the size that falls within the slight / minor category ($\leq 5\text{mm}$), we recommend that this area be monitored for further movement to ascertain structural stability over a period of 12 months. A structural engineer should be engaged to comment upon and offer further advise regarding the above issue if cracking continues to increase during this period. **See (Floors) for further findings and information.**

slight separation noted to bed 1 wall

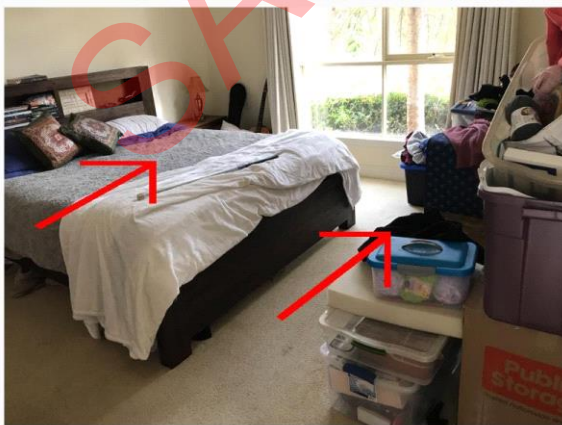
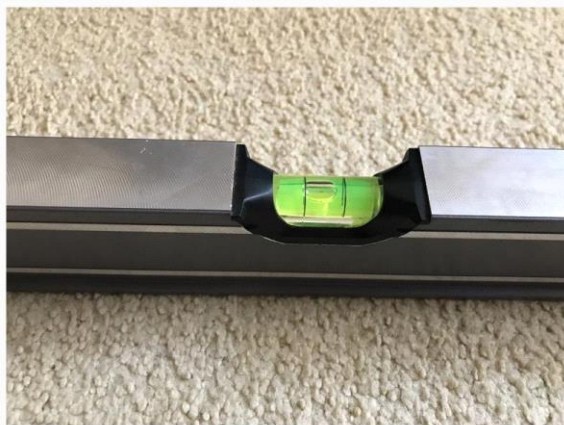
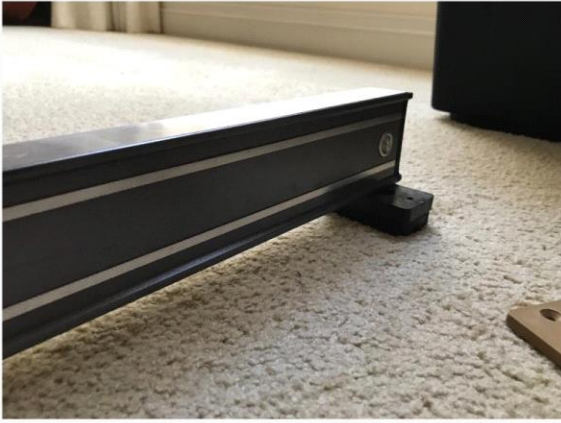
MINOR STRUCTURAL DEFECT: Floor areas within the main bedroom as shown are visible uneven. The feel of downward movement can also be experienced walking from the doorway toward the front elevation. We measured floor levels on the day and found localised downward deviations from level plane (rear to front elevation) within the main bedroom at ~20mm (accuracy concessions for carpet linings required). In the opinion of the inspector, this is due to footing (slab) subsidence from poor foundation (soil) conditions below the front elevation. Further external investigations revealed the foundations conditions below affected areas appear compromised and installed footing systems may no longer be providing adequate bearing for directed loads over these areas. See (EXTERIOR) for further findings and information. See photos for examples.

area of level deviation within bed 1

deviation from level over 1.8m example

deviation from level ~20mm over 1.8m

We recommend a structural engineer be engaged to comment upon and offer further higher level advise regarding the above issue.

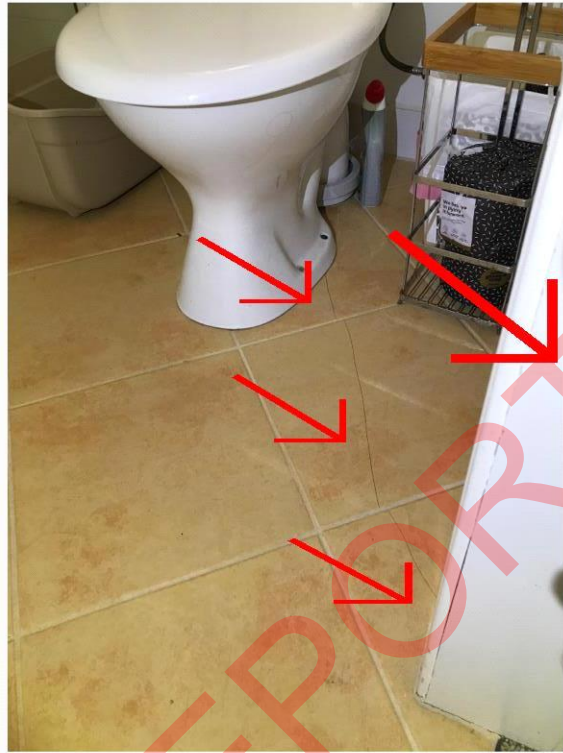
tile cracking from slab movement viewed

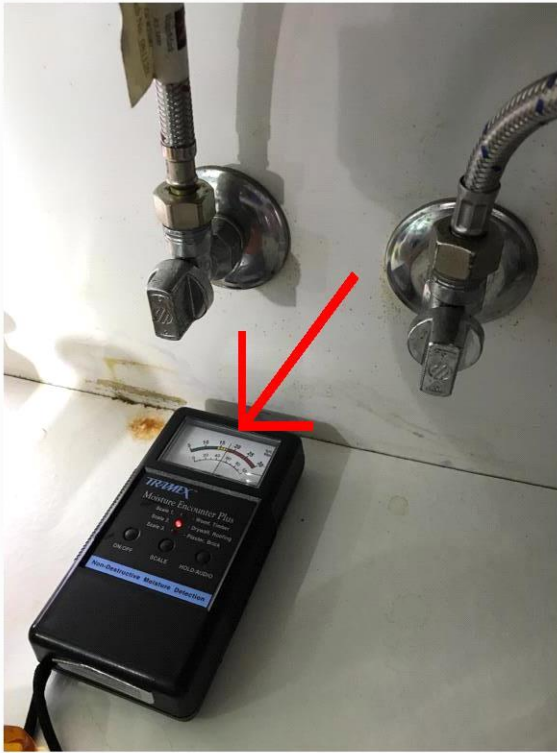
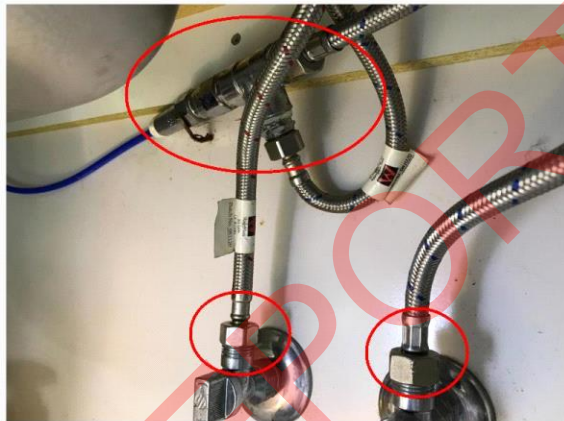
Water supply connections appear to be leaking and elevated moisture was recorded to the under sink shelf. A licensed plumber should be called to make further evaluation and repairs as needed.

elevated moisture recorded example

have plumbing connections assessed

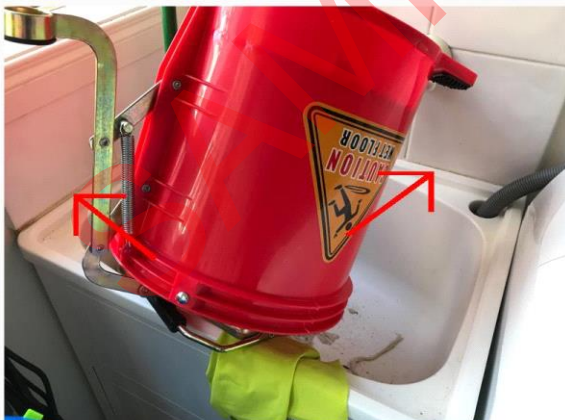
A flexible silicon sealant should be provided to the junctions between the trough tub and tiled splashback to provide an acceptable finish and prevent water penetration.

junction sealant required example

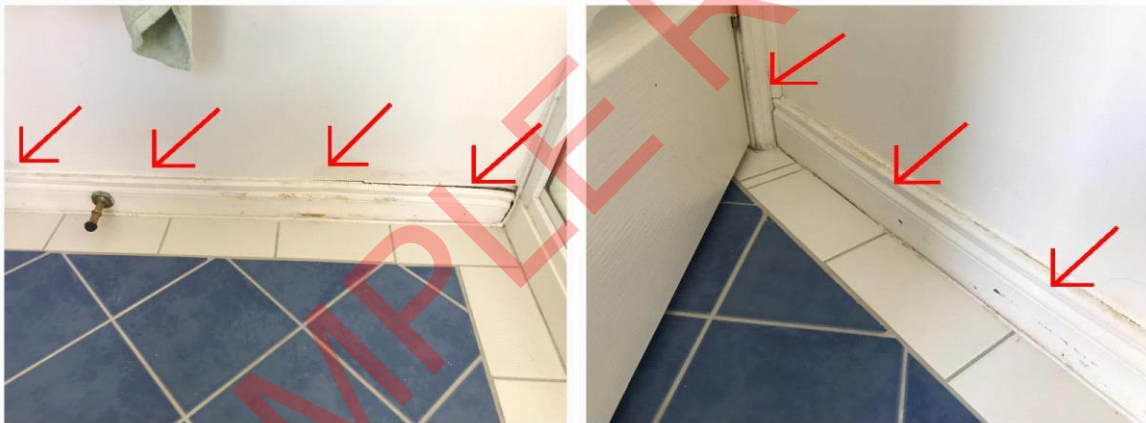
Concealed leakage and / or moisture spread damage was viewed to surrounding components and wall framing members as shown. Further investigation and rectification will be required and the extent of works should be determined by a licensed builder.

visible shower leak defects noted

swollen door & trim timbers visible

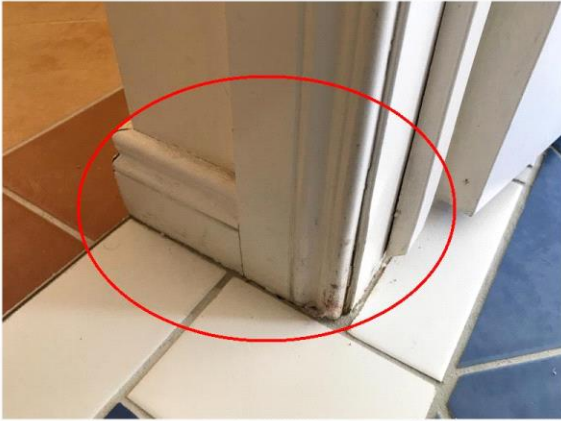
swollen door & trim timbers visible

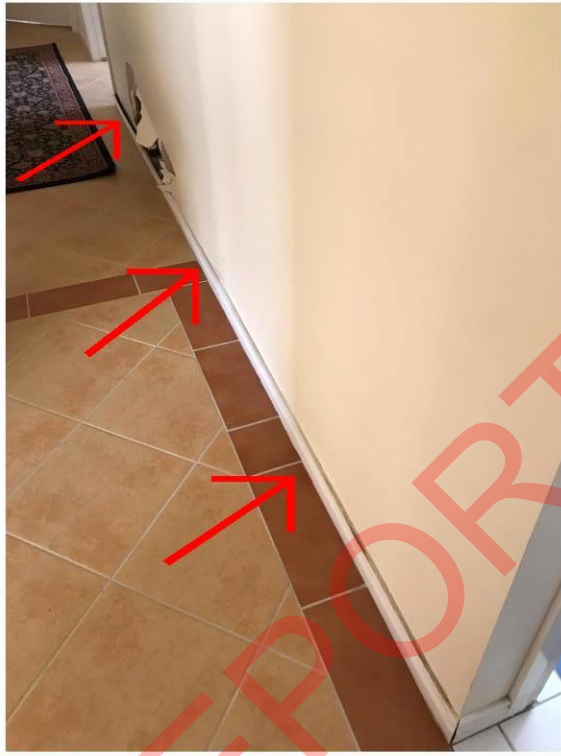
visible shower leak defects noted

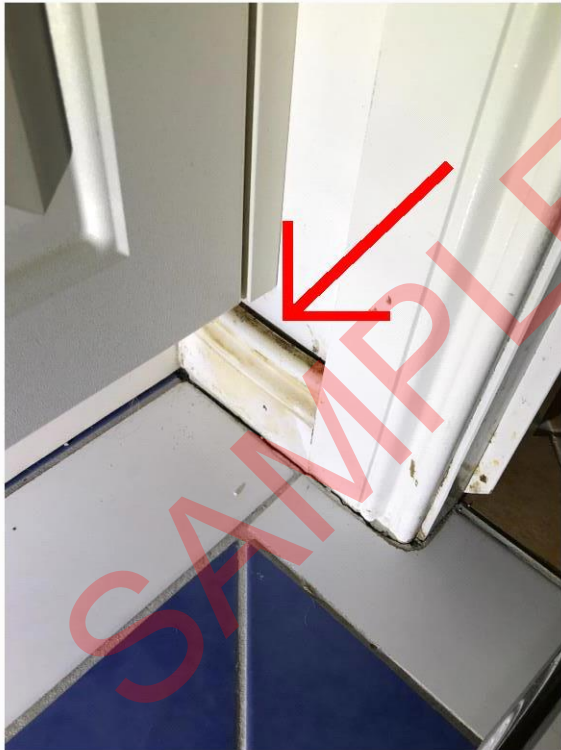
visible shower leak defects noted (laundry

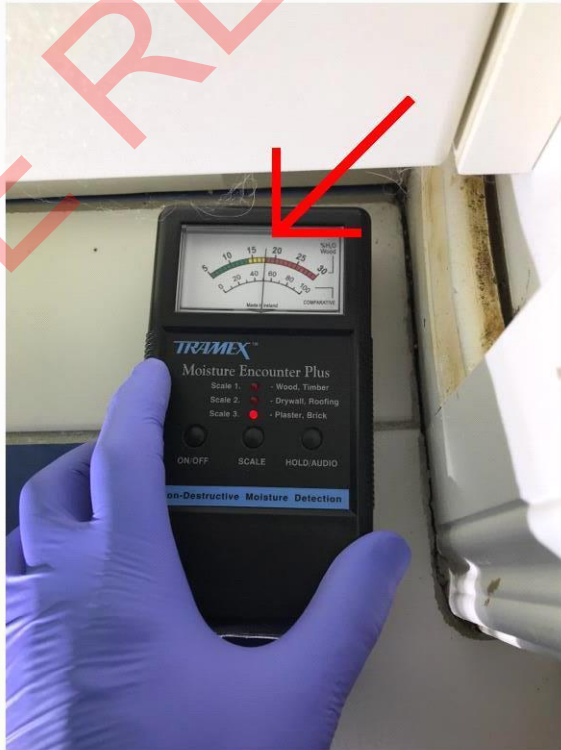
high moisture to ldry floor from shwr leak

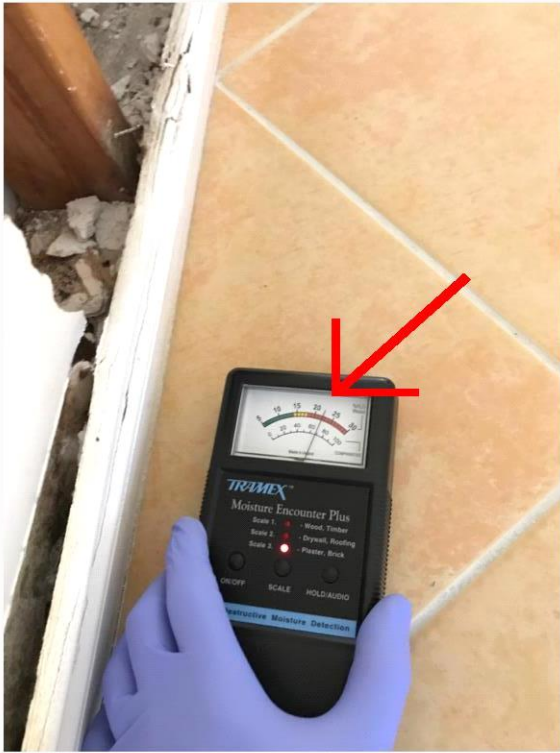
high moisture to hall floor from shwr leak

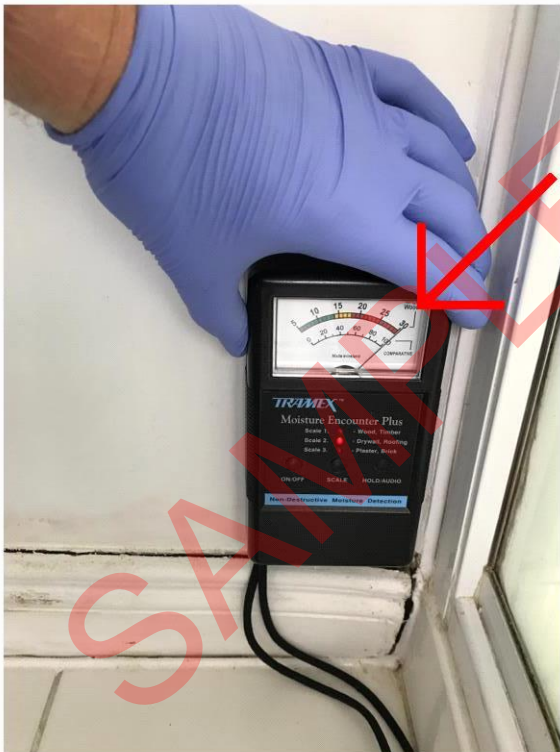
high moisture recorded to adjacent wall

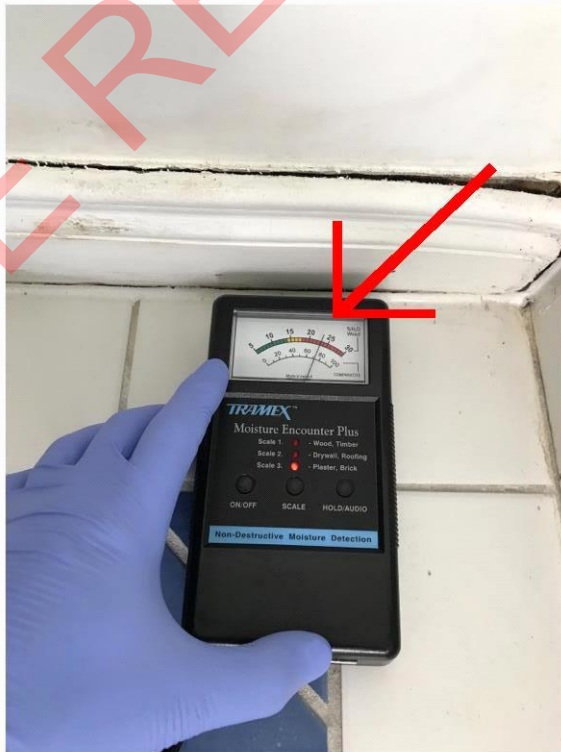
high moisture recorded to adjacent floor

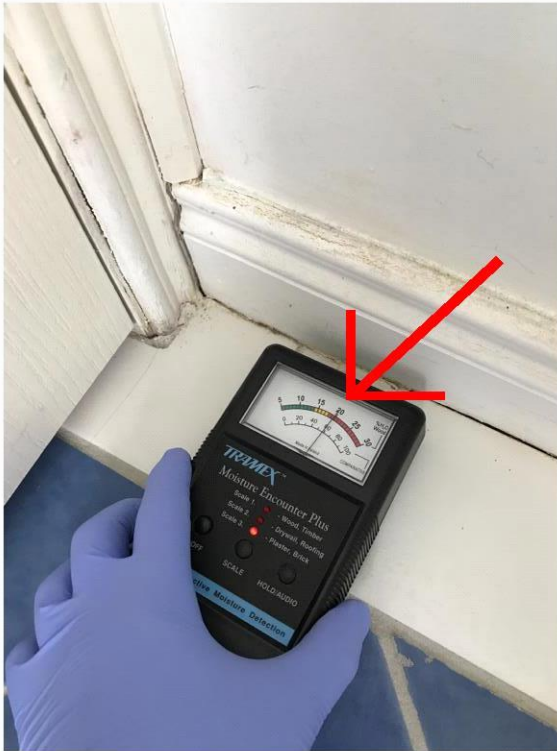
high moisture recorded at bath door

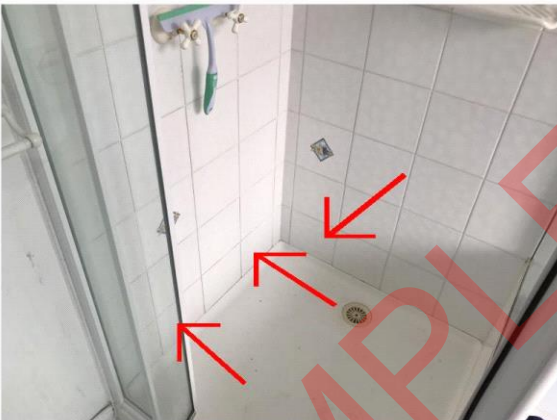
high moisture recorded to recess walls

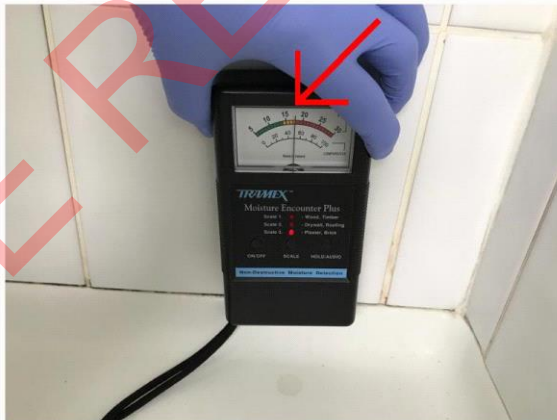
high moisture recorded to recess wall tile

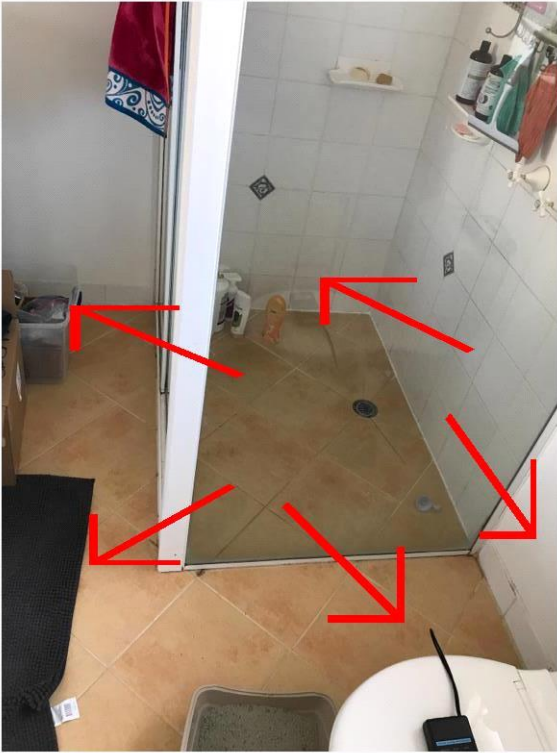
IMPORTANT NOTE: It is also unknown if a water stop has been installed / detailed under the shower screen as required by Australian Standards.

water spread from walk-in shower active

Further assessment, a scope of works and rectification should be determined by a licensed builder.

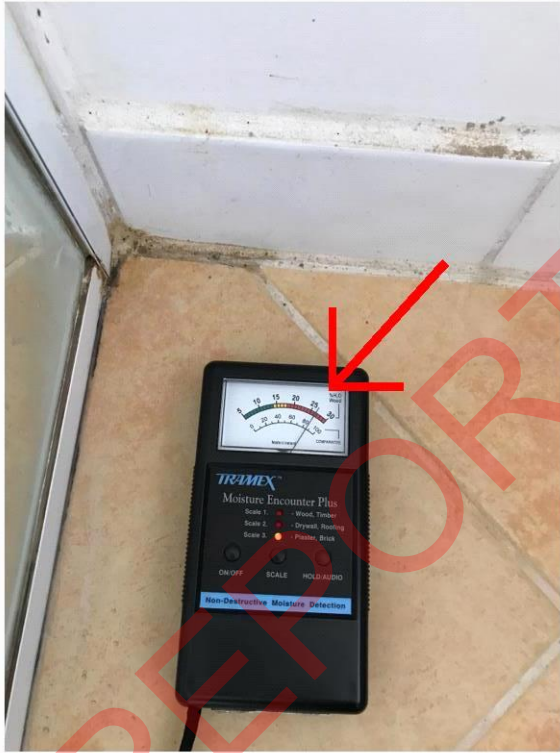
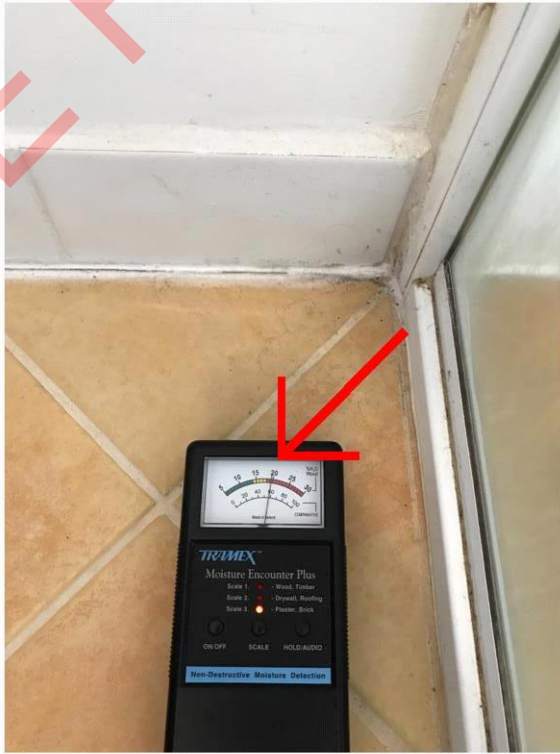
high moisture recorded to floor tile

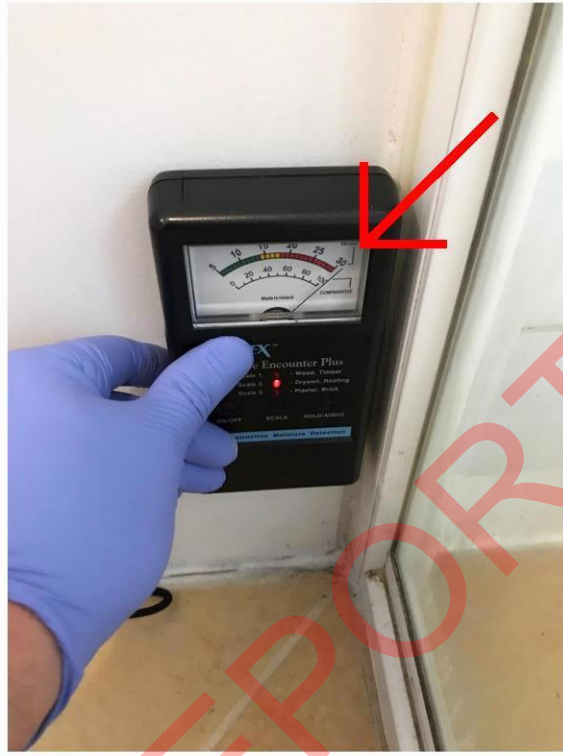
high moisture recorded to wall lining (LS)

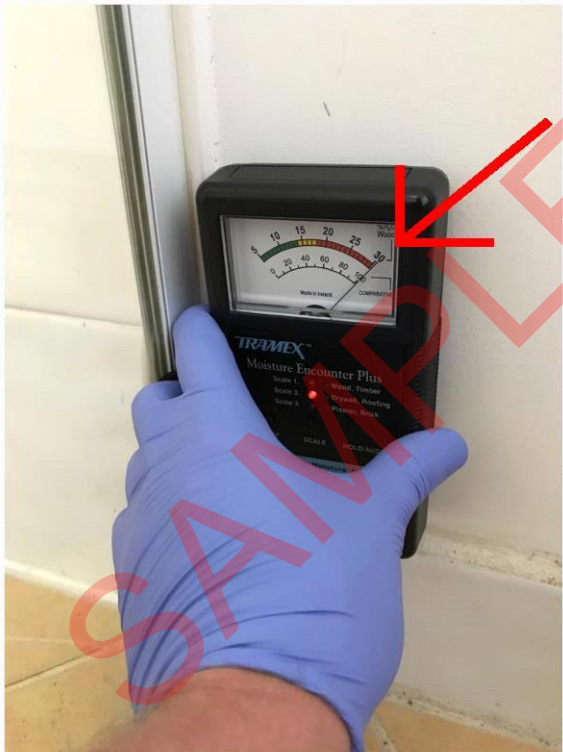
high moisture recorded to wall lining (RS)

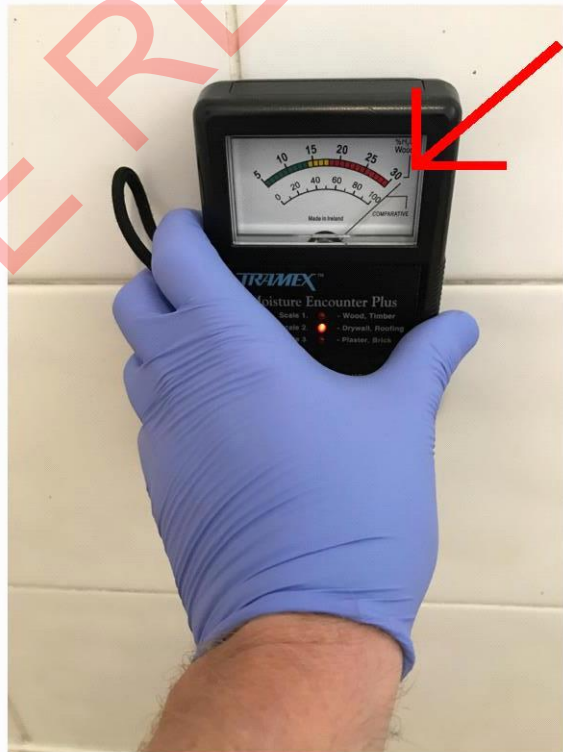
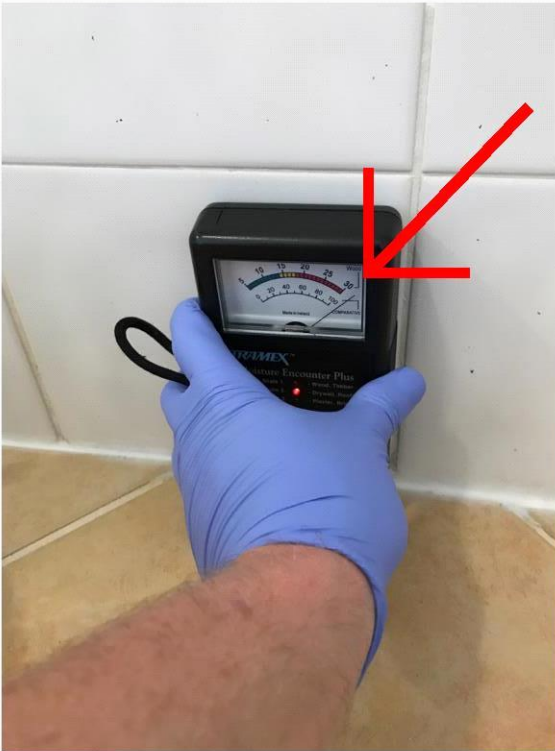
high moisture recorded to recess wall

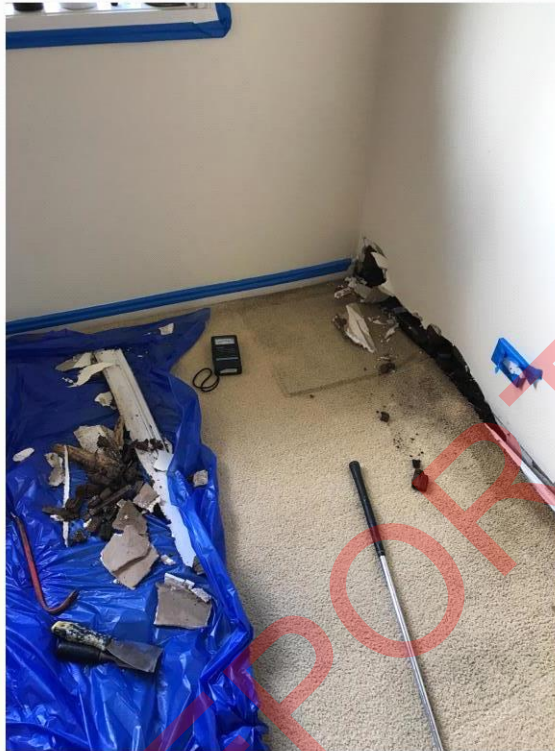
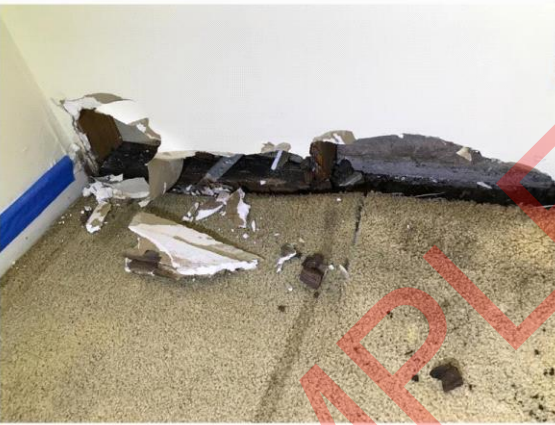
water staining viewed & strong odour

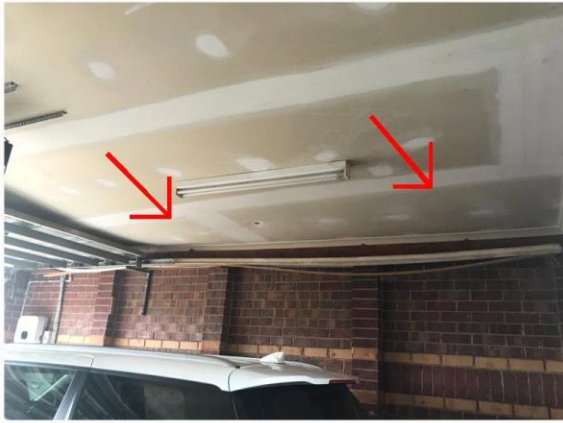
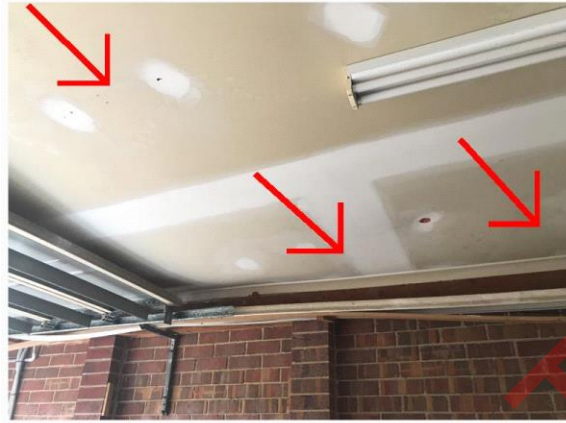
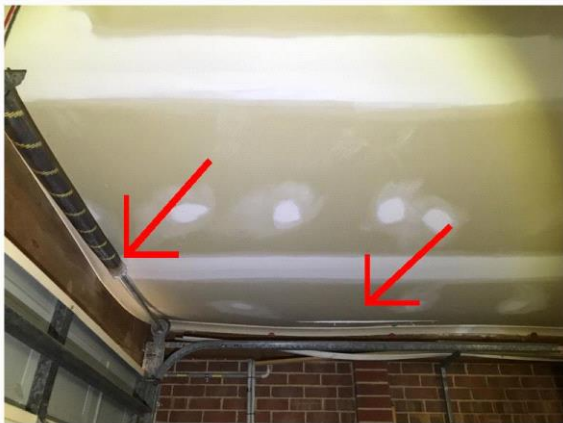
MAJOR DEFECT: Undulations and sagging / deflection was noted to the ceiling linings mainly concentrated to the left side of the garage. This is the result of lack of adhesion to joists and vibration stress and the warning signs that the ceiling may collapse. We note there is no evidence of prior / current water penetration to ceiling linings from defective roofing above.

visible sagging of ceiling example

As the ceiling is vulnerable to collapse and poses a safety risk to occupants, this is classed a **major defect**. Immediate steps to secure / brace the ceiling linings should be undertaken and refix the sheeting where the fastening systems have failed. It is strongly recommended a suitably qualified / licensed plasterer be called to make a further evaluation and repairs or rectification as needed.

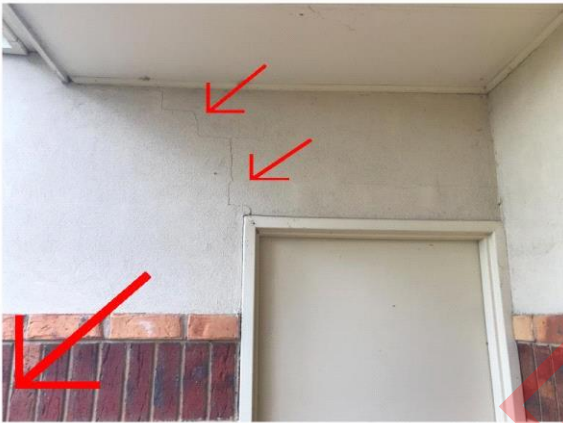
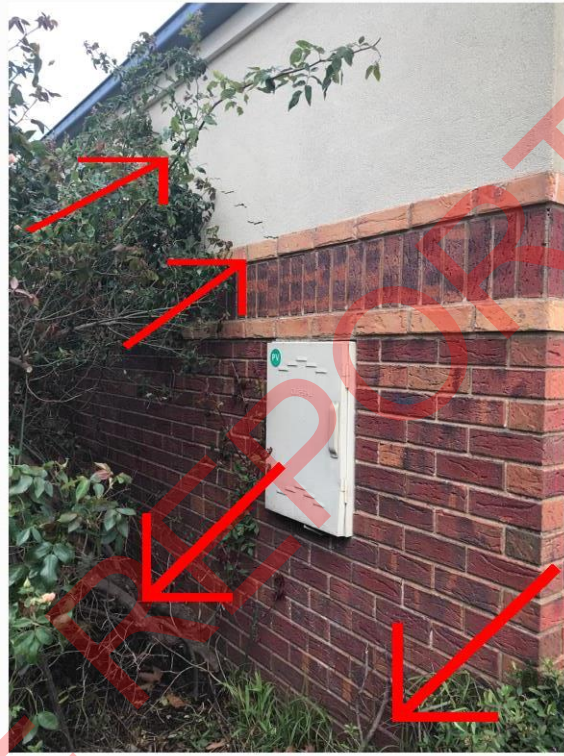
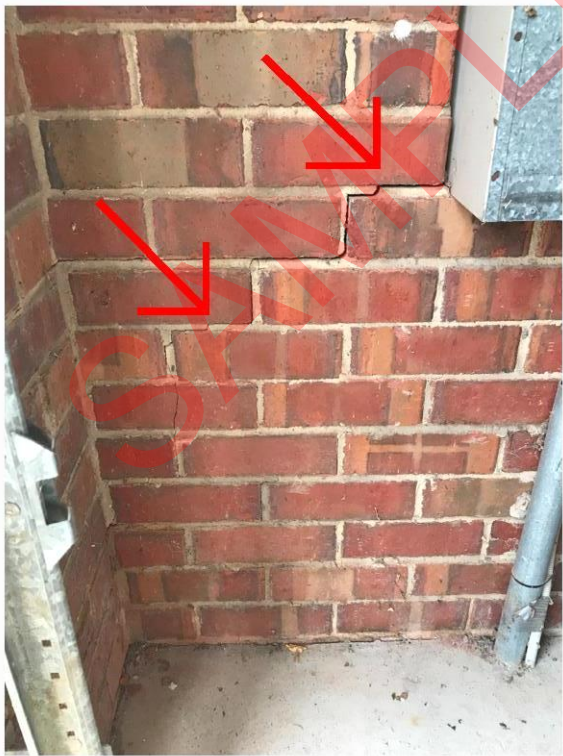
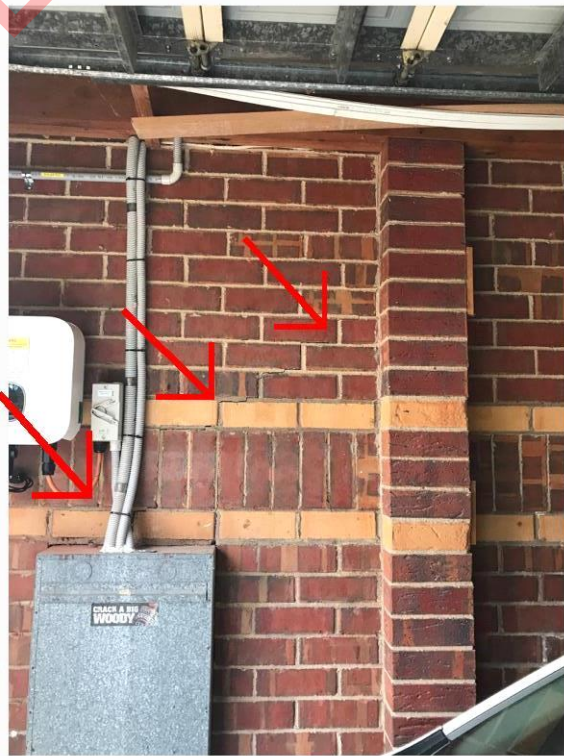
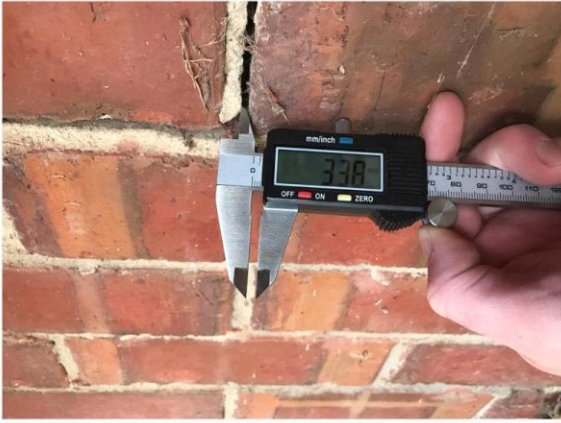
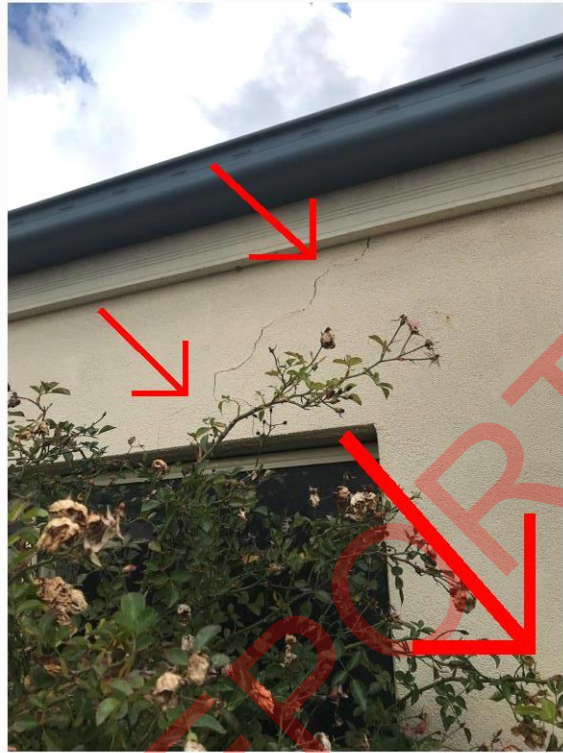
movement cracking viewed to garage wall

measured garage wall crack example

movement cracking viewed to rear garage

IMPORTANT NOTE: It is always recommended that a soil test with structural engineers report investigate and determine the significance of any cracking / movement to walls, we are unable to determine the significance of the cracking inside a Pre

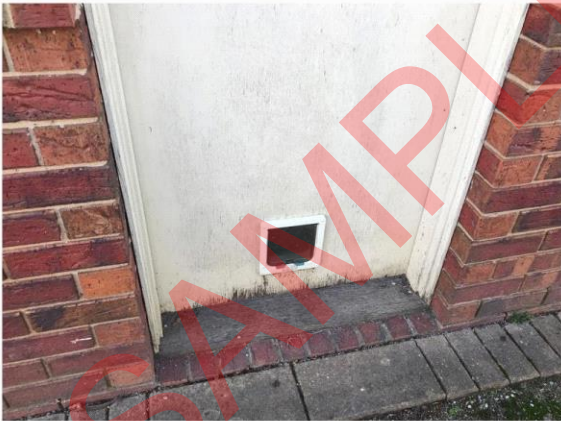
Paint peel from age and weathering is present to the laundry door, frame / jamb and threshold as shown. Maintenance will be required and a painter should be called to make a further evaluation and repairs or rectification as needed. We also recommend a weather/storm strip be fixed to the bottom of the door to prevent any potential water ingress.

weathering to exposed door example

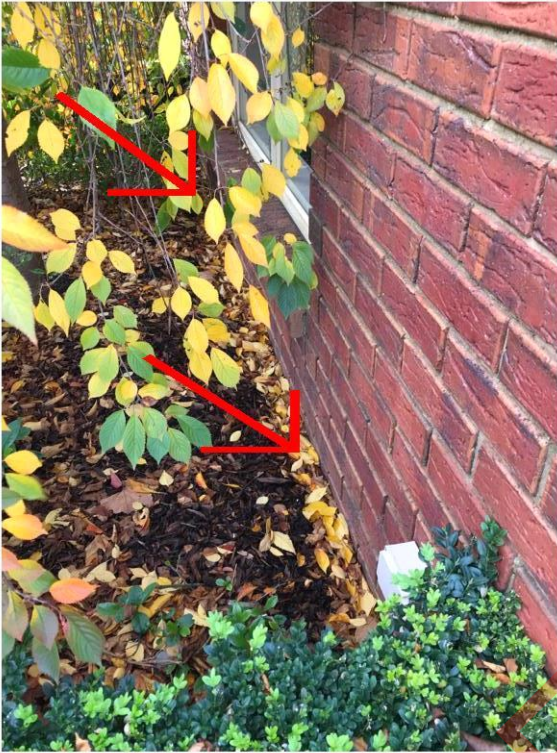
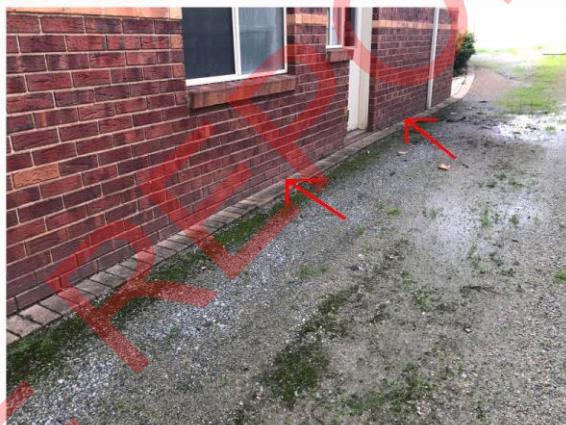
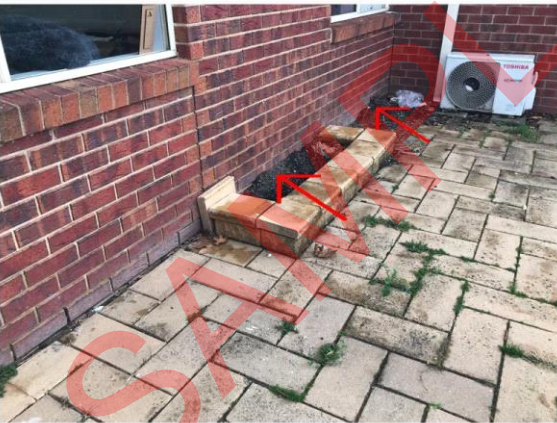
The weep holes (vertical slots to the base of the brick walls) are blocked in some areas as shown. These may have been blocked by gardens or levels of external paths and/or patios. Weep holes are necessary to allow moisture to be removed from and to ventilate the wall cavity. This issue may also compromise any pest management to the structure. Rectification is recommended.

weep holes covered example (front bed 1)

weep holes partly covered example

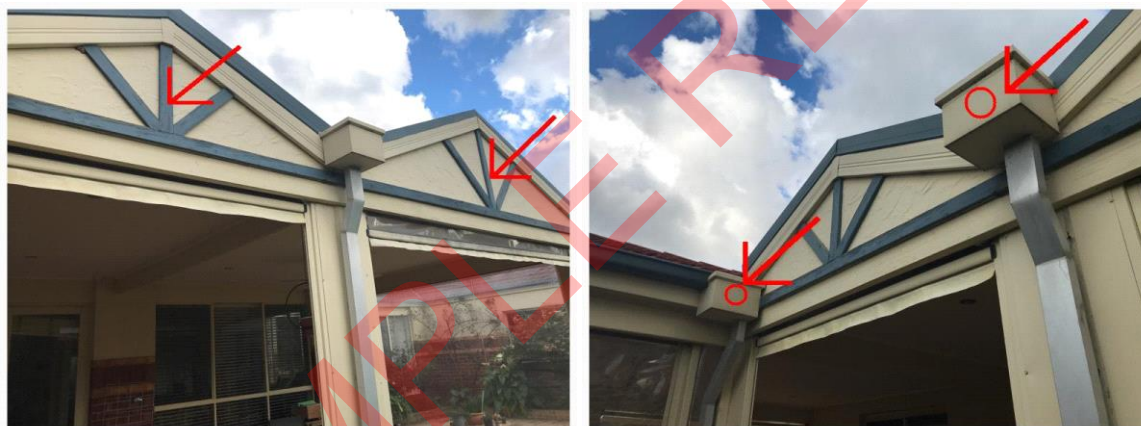
Gable strapping timbers require painting to prolong the life of the materials. A licensed painter should be called to make a further evaluation and repairs or rectification as needed.

The installed rainheads do not appear to have overflow provisions cut in correctly and as such backflow to guttering may occur during heavy rain events. A licensed roof plumber should be called to make a further evaluation and repairs or rectification as needed.

paint protection required example

cut in overflow provision to rainheads

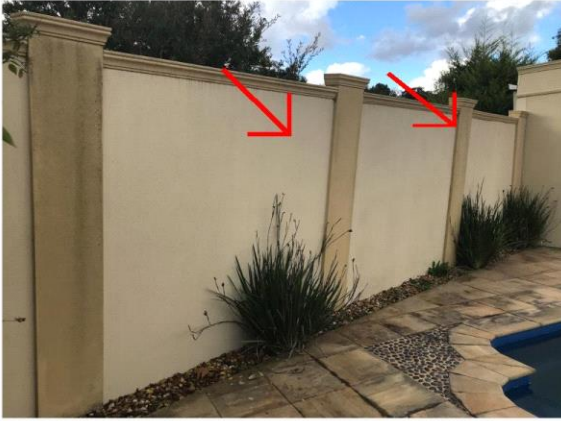
The left side fence adjacent to the pool is leaning and repairs may be required in the short term. A licensed carpenter or landscaper should be called to make a further evaluation and repairs or rectification as needed.

leaning noted | heavy cladding

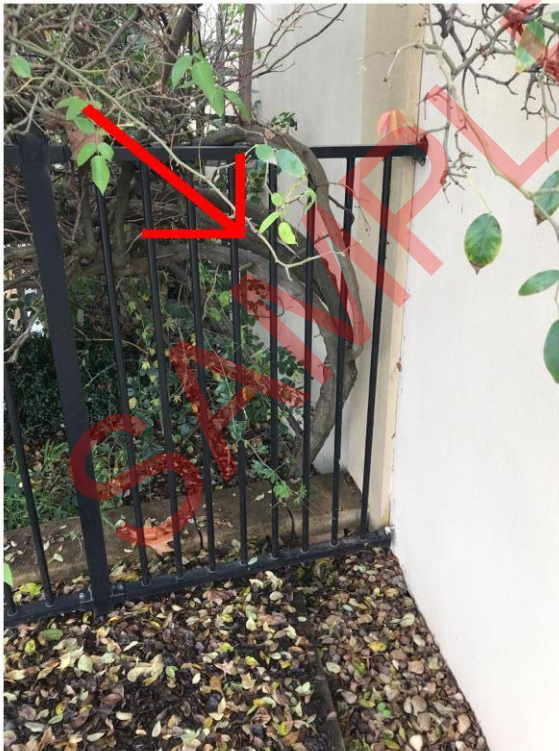
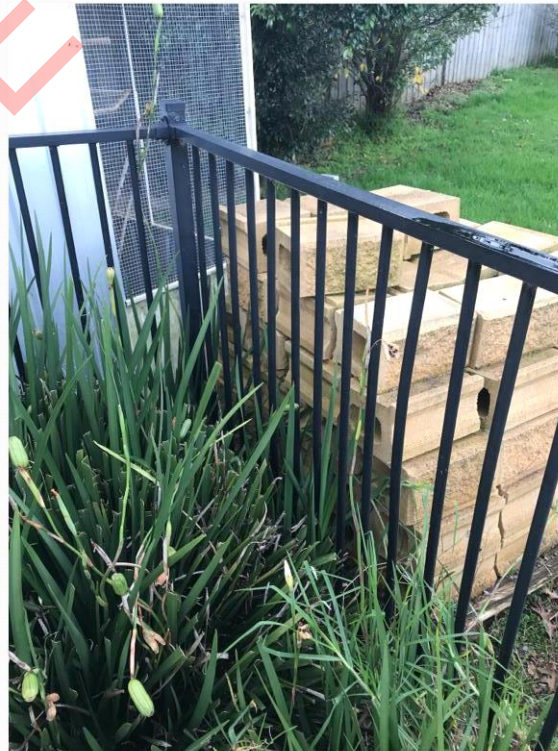
MAJOR DEFECT: A swimming pool is present but the pool fence / safety barrier has adjacent climbable zone(s) within the acceptable distance / tolerance. The pool fence should be checked for compliance with safety regulations. An inspection should be conducted by a specialist pool inspector to determine the condition of the pool, pool equipment and surrounds.

This in the opinion of the inspector and in accordance with AS 4349.1 - 2007 is considered a **major defect** as it presents an immediate safety risk to occupants.

established tree within climbable zone

brick stack within climbable zone

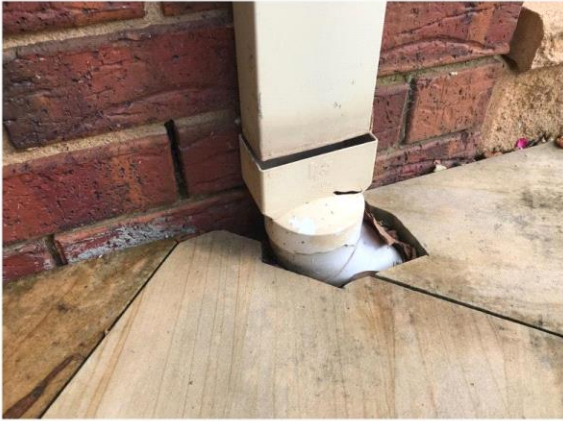
DP not connected to PVC adaptor

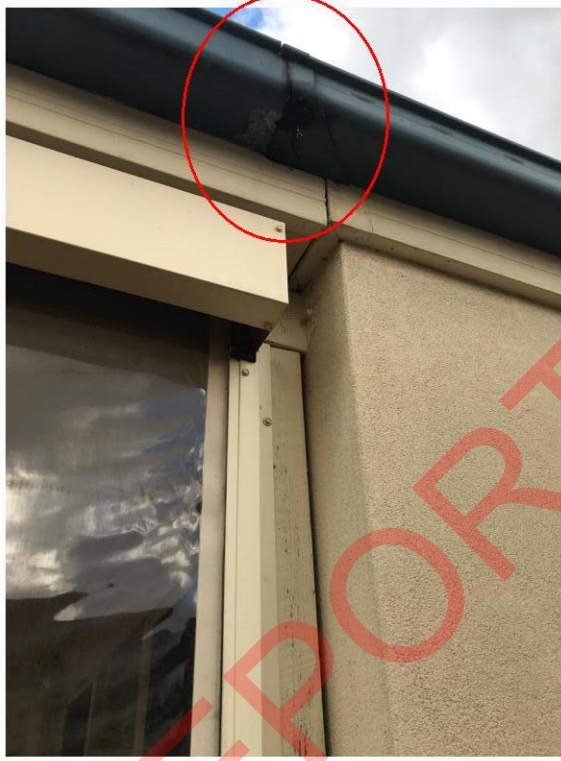
Guttering joints to the left elevation are leaking and should be repaired.

make good / rework gutter joint leaks

We recommend the guttering system and rainwater tanks (if any) be monitored during heavy rainfall to determine if there is any inadequacies. A licensed roof plumber should be called to make a further evaluation and repairs or rectification as needed.

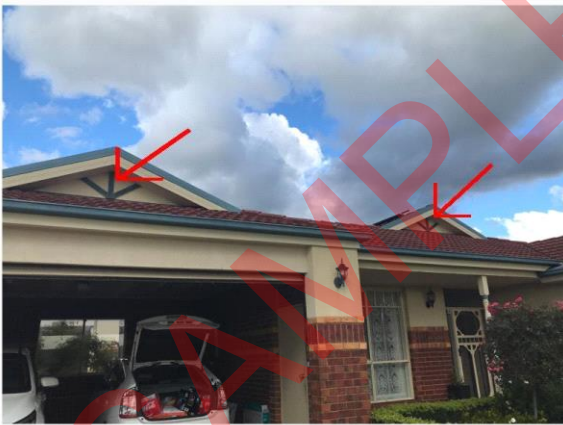
Wet rot decay and paint peel is present to gable strapping timbers as shown and maintenance is required. A licensed carpenter and painter should be called to make a further evaluation and repairs or rectification as needed.

rework gable timbers example

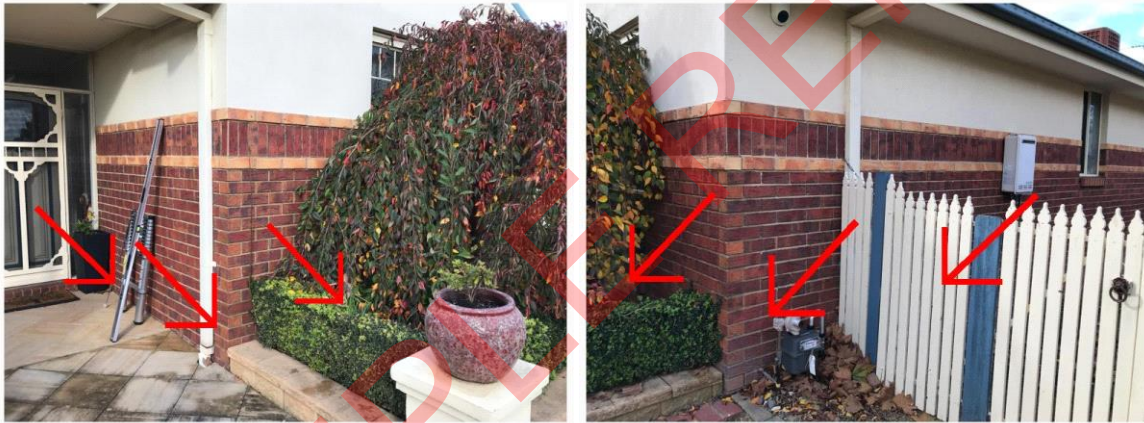
Note: Structural movement may be a result of excessive and opposing changes in moisture levels of the foundation soils below footings and the site. Differential settlement in a house of this age and construction type is usually due to ground movement of reactive soils as moisture levels change over time and go beyond the design limits of the footing system constructed.

slab subsidence noted to main bedroom

Some maintenance to internal and external components and observations / monitoring (crack dairy) will be required in the short term to establish a time line for footing stability during advised site rework. Rework options may include removal of garden beds and trees in close proximity to house footings, re-grading of surrounding grounds / paths to provide fall, additional surface drainage provisions and roof drainage components assessed is recommended. We recommend a structural and geotechnical engineer evaluate the area for foundation stability and offer higher level advice regarding the above issues as needed.

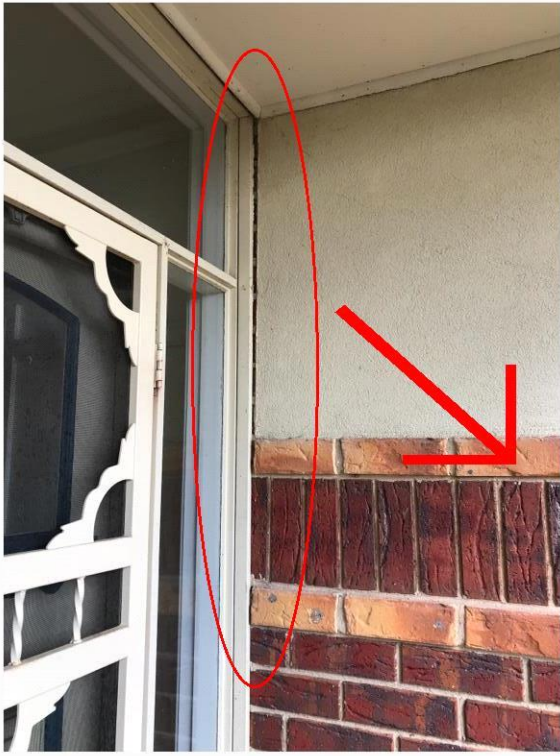
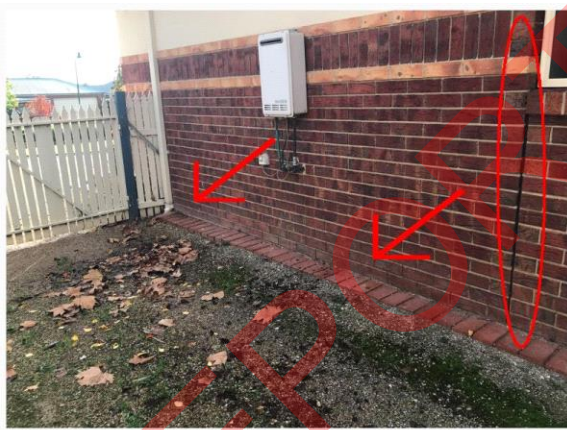
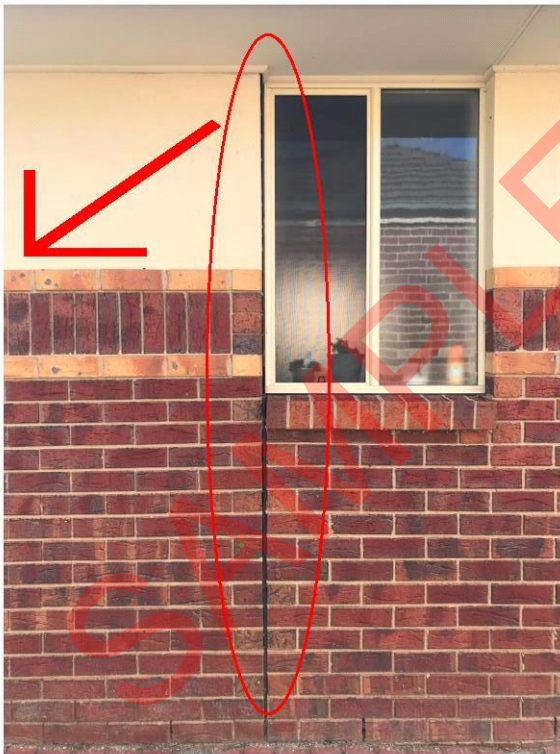
separation noted to wall|drop toward front
