Northern House Inspections

Special Purpose Inspection Report

Narre Warren North, VIC 3804

May 20, 2020

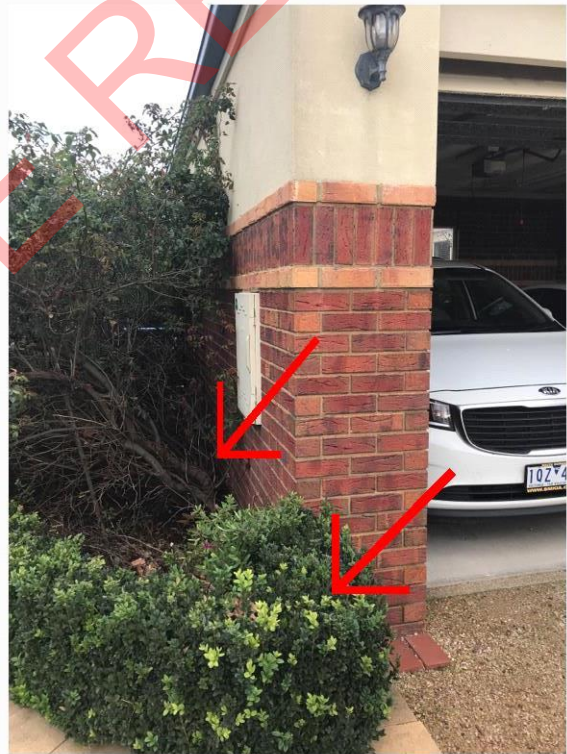
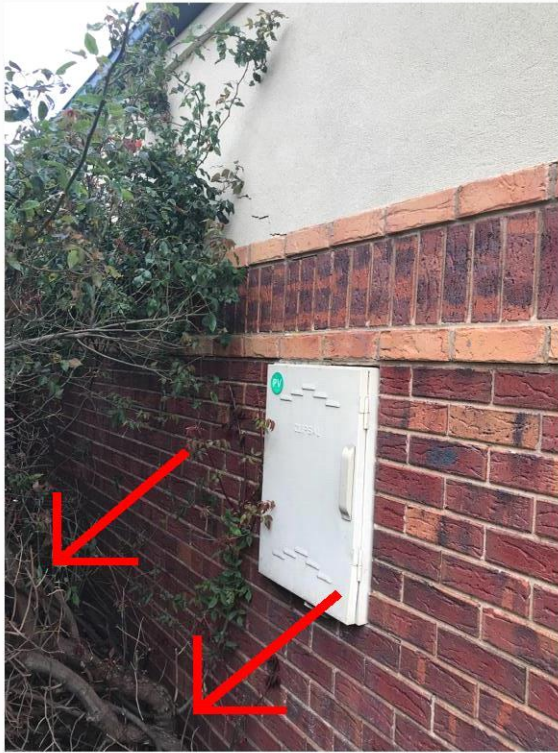
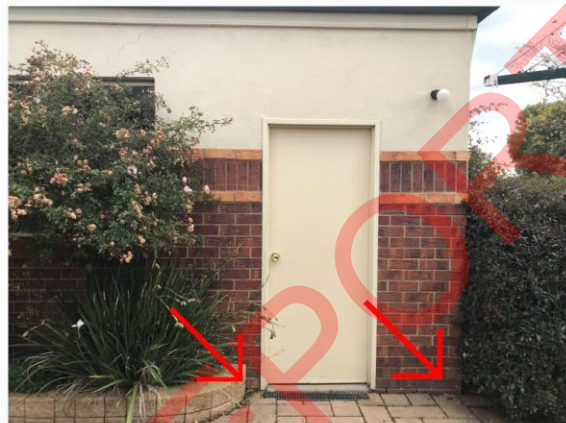
subsidence noted to strip footing
