Northern House Inspections

Pre Purchase Inspection Report

154 *****

Eltham North, VIC 3095

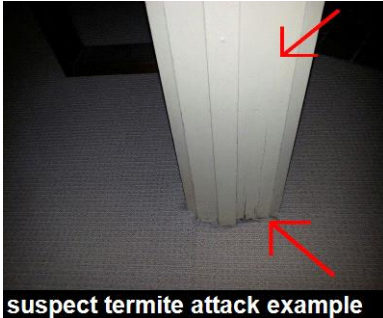
Evidence of what appears to be timber pest attack was noted. The visible damage appears to be localised to the door jamb of the master bedroom. We strongly recommend an inspection by a qualified pest inspector be commissioned.

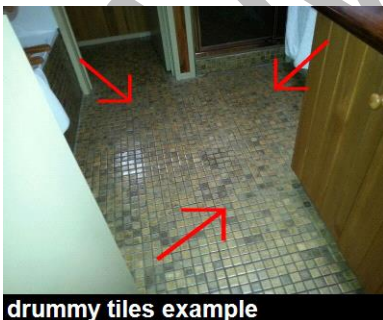
Some drummy floor tiles were noted in this area. These will require relaying if they become loose over time. A licensed floor and wall tiler should be called to make a further evaluation and repairs or rectification as needed.

drummy tiles example

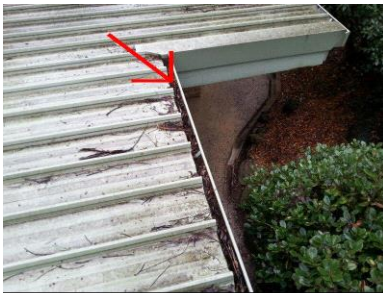
Leaves and organic debris are heavily present in gutters of the dwelling. These should be cleared to prolong the life of the guttering material and prevent any stormwater blockage and subsequent water ingress to the dwelling. Ongoing maintenance and/or some form of gutter guard is suggested.

**gutter blocked by debris
example**

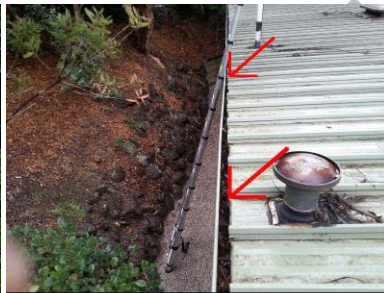
**gutter blocked by debris
example**

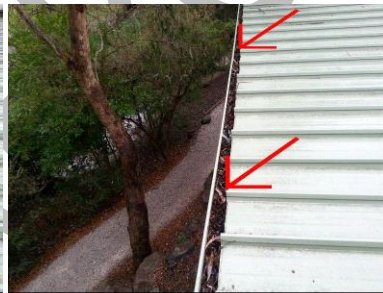
**gutter blocked by debris
example**

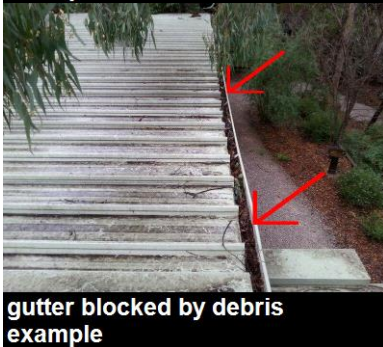
**gutter blocked by debris
example**

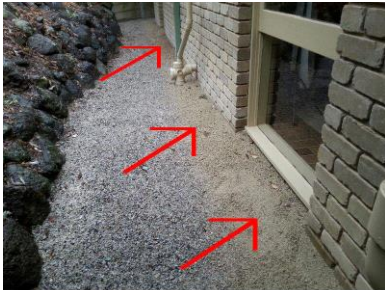
The base of some walls and windows are below the external soil levels and may be subject to lateral dampness, wet rot decay or water entry. In this case, it is recommended that either soil levels be lowered, re-graded or the area concreted and an agricultural / trench drain be installed to pick up excess water. The ag drain is to be installed as per relevant Australian Standards and be connected to the storm water system by a licensed plumber. Furthermore, these areas should be closely monitored for water entry/penetration, see (SITE) for further information.

lower ground level to gravel paths

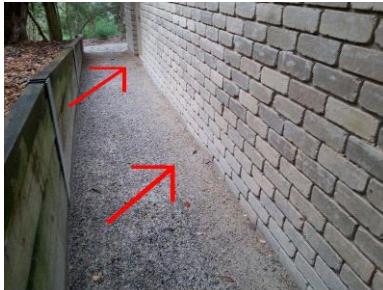
lower ground level to gravel paths

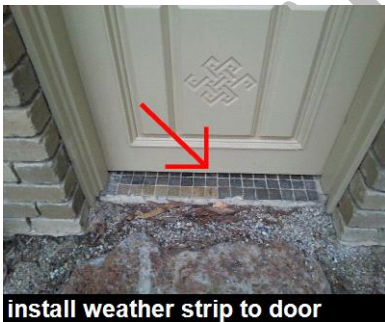
install weather strip to door

We recommend a weather/storm strip be fixed to the bottom of the door to prevent any potential water ingress to the laundry area.

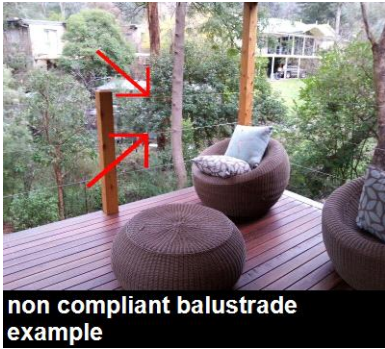
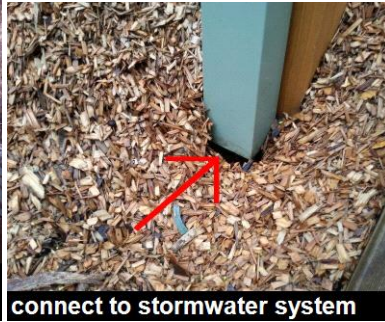
The handrails and balustrades do not appear to comply with the current BCA Standards for height and spacing. Although this report does not generally comment on items of compliance, this issue may become a safety issue and therefore was included in this report. Recommend you further investigate this matter and upgrade if necessary. This in the opinion of the inspector and in accordance with AS 4349.1 - 2007 is considered a **major defect** as it presents an immediate safety risk to occupants. Moreover, the area appears to have a drop greater than 1 metre from the floor and compliant handrail and balustrade wires should be installed. A licensed carpenter should be called to make a further evaluation and repairs or rectification as needed.

The downpipe does not appear to be connected to the stormwater dispersal system. This may or may not be a contributing factor to poor drainage in this area. This should be rectified to prevent decay to surrounding components. This also effects the timber pest management of the property. A licensed roof plumber should be called to make a further evaluation and repairs or rectification as needed.

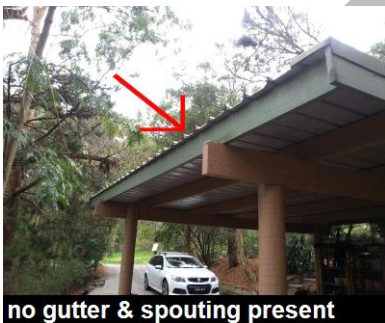
Gutters and/or downpipes are not present to this roof area to direct water into the stormwater, street curb or retention system. Recommend guttering be installed. A licensed roof plumber should be called to make a further evaluation and repairs or rectification as needed.

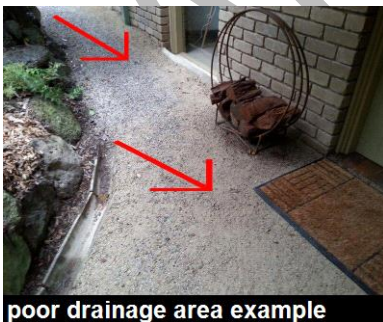
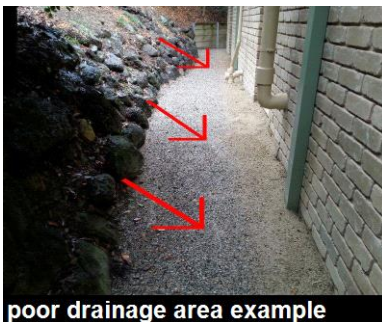
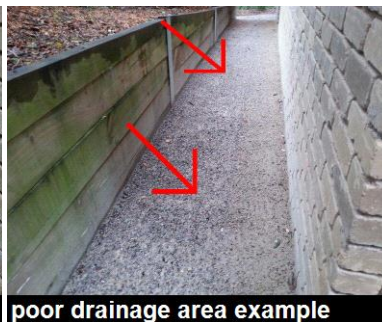
The drainage at the left and rear sides of the property appears inadequate. As a result, evidence suggests that surface water has been ponding and/or being directed toward the footings. Poor site drainage can create unstable foundations that may have an adverse structural effect over time. Rectification is required. Drains should be installed to divert seepage and surface runoff water away from the house. The drains should be connected to the existing stormwater drainage system. Please contact a Licensed Landscaper or Builder for further information.

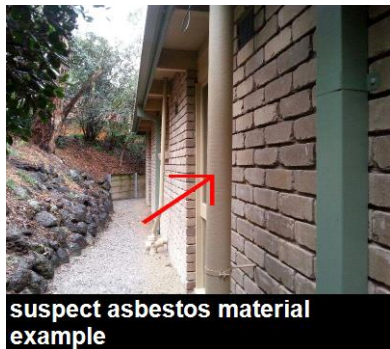
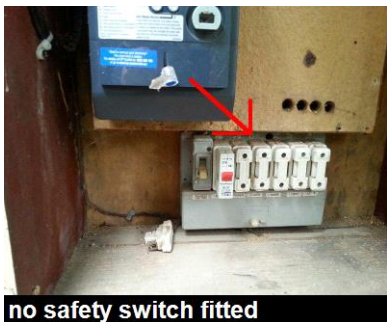
The sewer vent pipe is made with asbestos cement material. Although we are not qualified in the detection of asbestos material, the material found may contain asbestos. Asbestos material should be removed by a suitably qualified removal contractor if required.

No residual current device (RCD) was noted in the electrical meter box. Whilst not necessarily required at the time of construction, it is recommended that an RCD be fitted. Please contact a Licensed Electrical Contractor for further information.

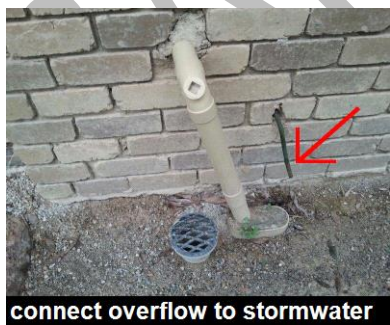
The hot water over flow pipe does not appear to be connected to the storm water system. This may effect the timber pest management of the property. We recommend the overflow be connected to the stormwater system by a licensed plumber.
