Northern House Inspections

Pre Purchase Inspection Report

8 *****

Epping, VIC 3076

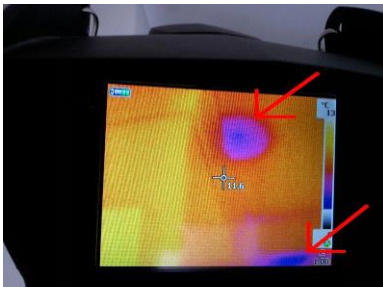
Evidence of current water penetration through to the ceiling lining is active within the hallway and laundry areas. We have investigated all roofing areas above and are able to visually identify broken roof tiles for potential water ingress. See notes within the (ROOF SYSTEM EXTERNAL) section of this report for further comments and findings. We recommend a qualified plasterer be called to make a further evaluation and repairs or rectification as needed.

thermal moisture spot example
(hallway)

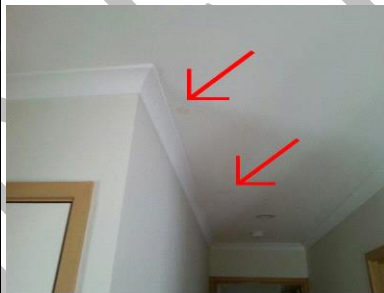
slight water staining evident

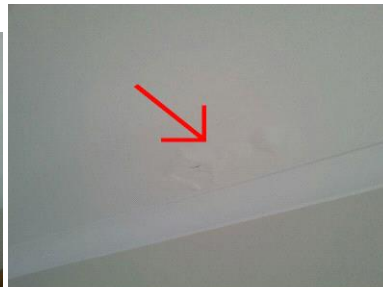
no active moisture recorded on
the day

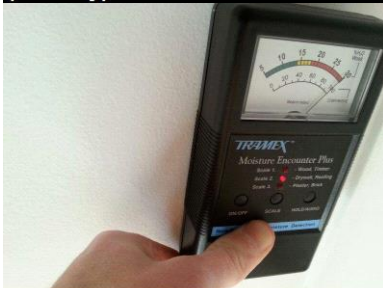
high moisture reading >25%
(hallway)

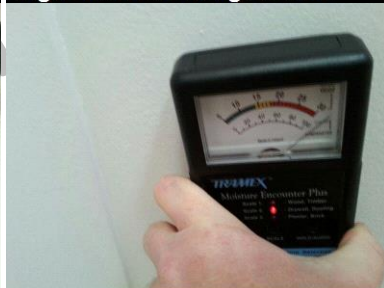
high moisture reading >30%
(hallway)

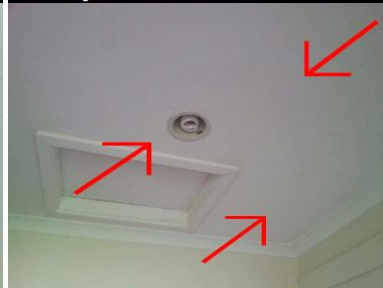
area of active leak
(laundry/manhole)

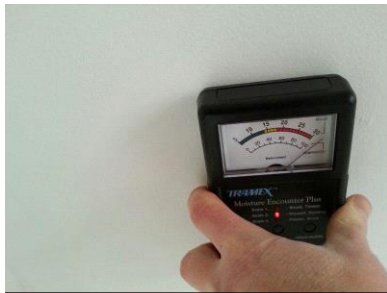
high moisture reading >30%
(laundry)

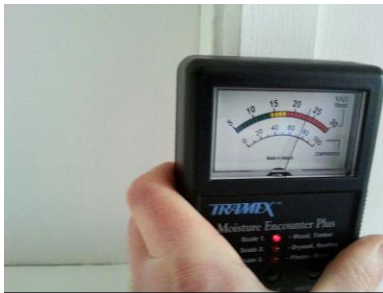
high moisture >20% (manhole-
timbers)

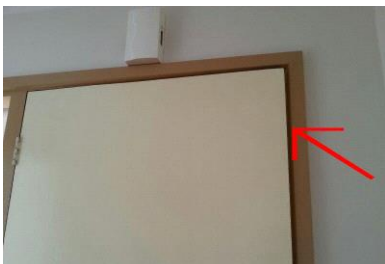
The condition of the doors is generally good. However, minor adjustment is required to the entry door that binds, to ensure a correct/smooth operation. We also note that the entry door/window frame has recently been replaced. This may be the result of previous termite attack evident to this area, see (SUBFLOOR) and refer to separate Timber Pest Inspection Report for further information.

binding to front door example

A licensed carpenter should be called to make a further evaluation and repairs or rectification as needed.

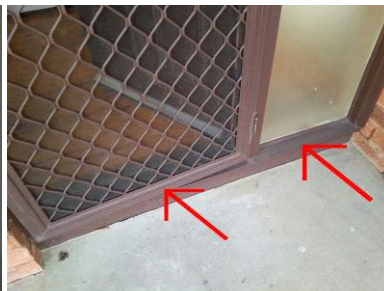
new frame/jamb timbers
installed

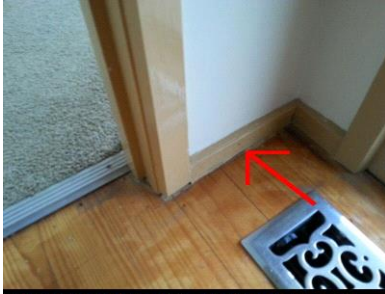
Evidence of what appears to be previous timber pest attack was noted to woodwork in the entry and master bedroom areas. Due to timber pest damage, some timber replacement may be required. The full extent of timber replacement was unable to be determined during this visual inspection and a more invasive inspection is required by a suitably qualified carpenter. Please refer to separate Pest Inspection Report for details.

suspect termite attack damage example

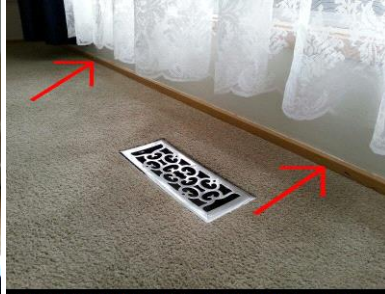
suspect termite attack damage example

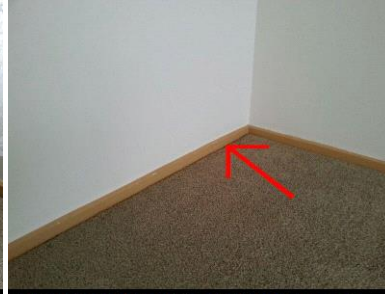
suspect termite attack damage example

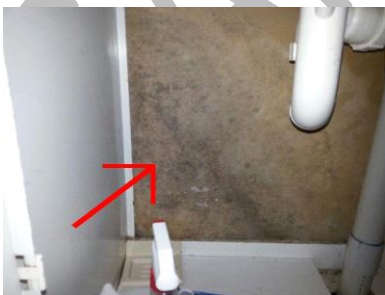
mould to installed MDF/remove & replace

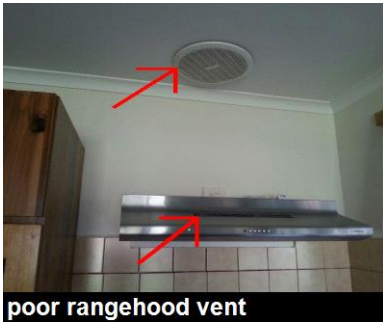
The rangehood does not appear to vent adequately to the roof void or the outside.

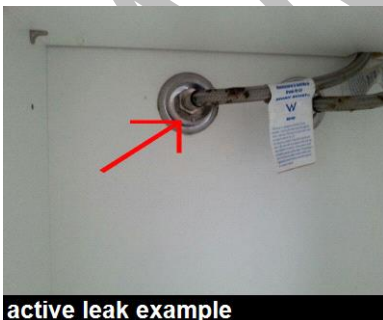
Leaks were noted/active to the lugged elbow and repairs are required. A licensed plumber should be called to make further evaluation and repairs as needed.

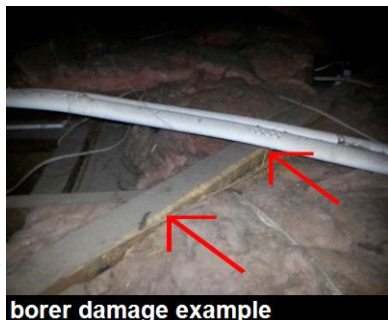
There appears to be minor damage consistent with timber pest attack which looks like Lyctus borer damage on bracing timbers above the entry hallway.

Lyctus borer is not considered to be a significant pest of timber as the damage is confined to the sapwood content of hardwood timbers, no treatment is usually required in respect of this borer. Please refer to the separate Pest Inspection for details.

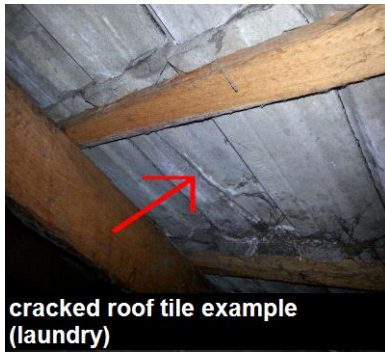
Minor to moderate water staining and leak damage was noted to roof framing timbers and plaster linings above the hallway and laundry. Further investigation to the roof tiles above these areas may be required to ascertain the source of the leak and be rectified. Decay damage was noted but not limited to the rafters, ceiling joists and battens to these areas. The extent of the visible damage has been categorised as a moderate defect to the building element(s), however all leaks and decayed timbers/plaster should be rectified.

cracked roof tile example
(laundry)

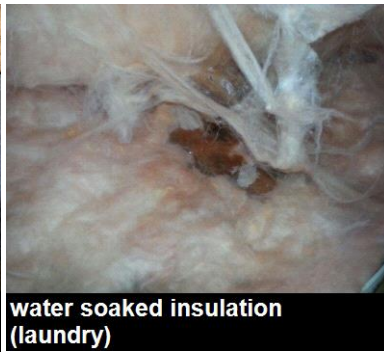
water soaked insulation
(laundry)

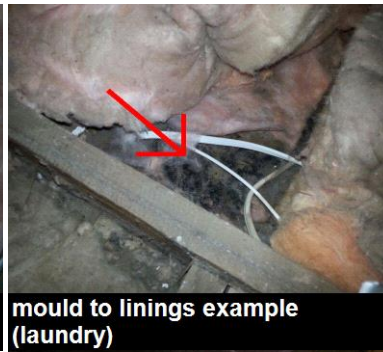
mould to linings example
(laundry)

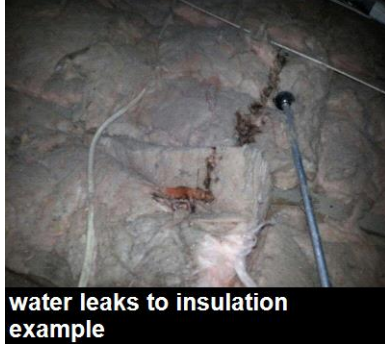
water leaks to insulation
example

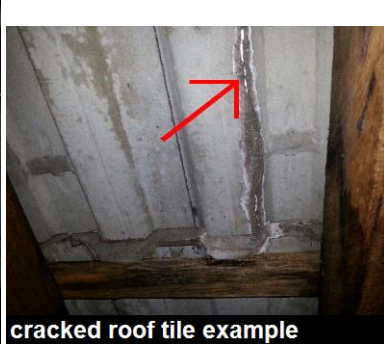
cracked roof tile example

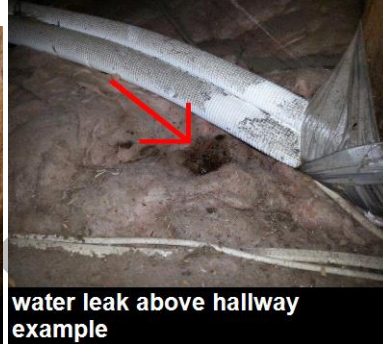
water leak above hallway
example

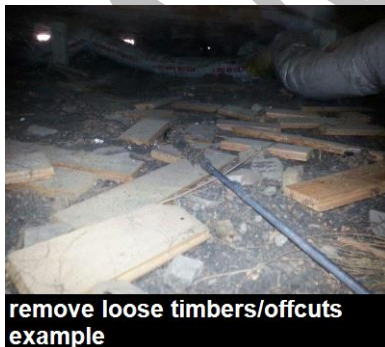
remove loose timbers/offcuts
example

Stored timbers and builders offcuts should be removed from the subfloor area. This will help manage any timber pest and/or termite attack to easily accessible timbers that are in contact with the soil.

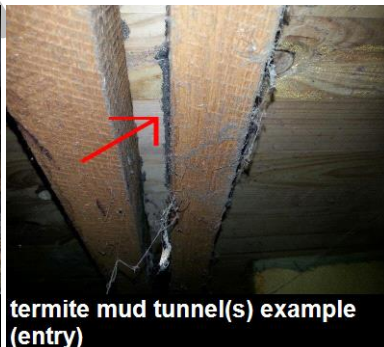
termite mud tunnel(s) example
(entry)

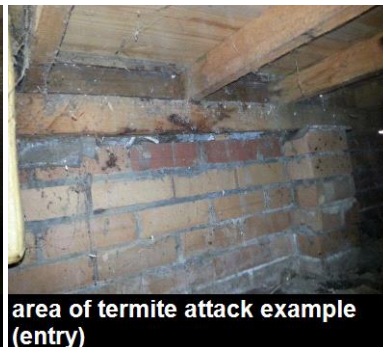
area of termite attack example
(entry)

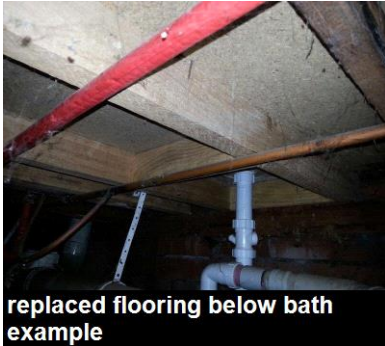
We note previous repairs/replacement to flooring and floor framing below the bathroom renovation.

replaced flooring below bath
example

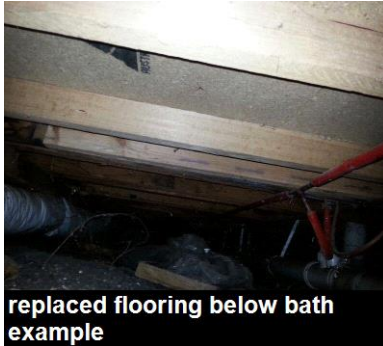
replaced flooring below bath
example

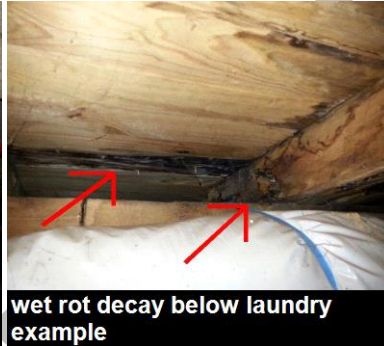
Moderate wet rot, fungal decay and staining damage was noted to flooring and floor framing below the laundry. This may be the result of leaks from a faulty washing machine fitting, drain leak or some other form of leak that was present to the laundry but not visible on the day. Moderate decay damage was noted but not limited to the floorboards, floor joists and bearers below these areas. The extent of the visible damage has been categorised as a **moderate defect** to the building element(s). A licensed builder should be called to make a further evaluation and repairs or rectification as needed.

wet rot decay below laundry
example

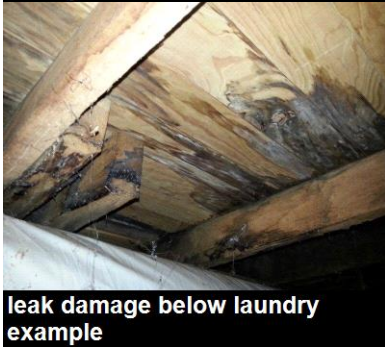
leak damage below laundry
example

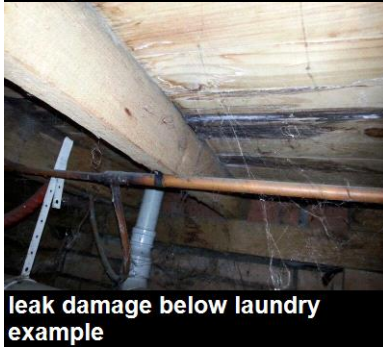
leak damage below laundry
example

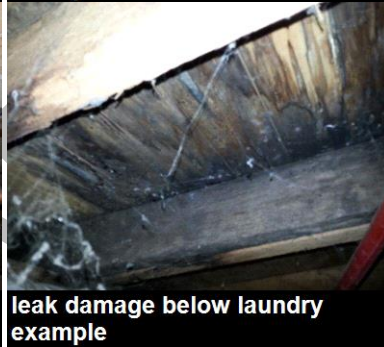
leak damage below laundry
example

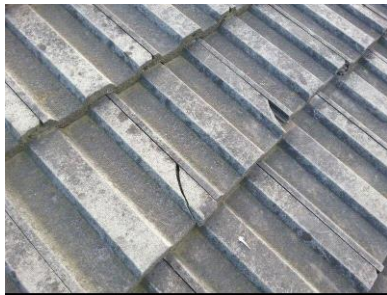
The overall condition of the roof coverings is poor as concrete roof tiles may require sealing to prevent moisture penetration. Also, mortar pointing and bedding to the ridge and hip cappings is cracked and requires re bedding and a large number of cracked roof tiles were noted and should be replaced as needed. A licensed roofing contractor should be called to make a further evaluation and repairs or rectification as needed.

cracked roof tile example

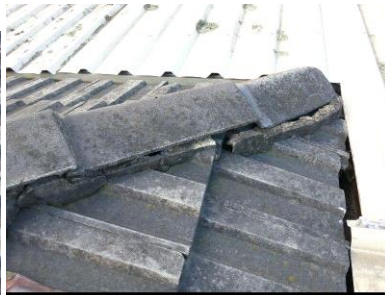
hip capping to be re-bedded/pointed

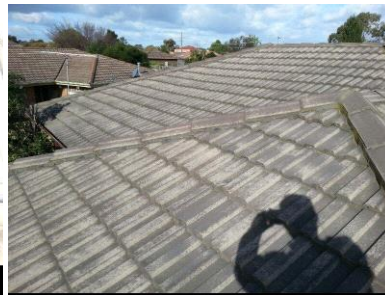
roof tiles require sealing

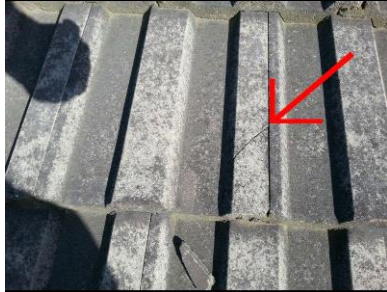
cracked tile above active hallway leak

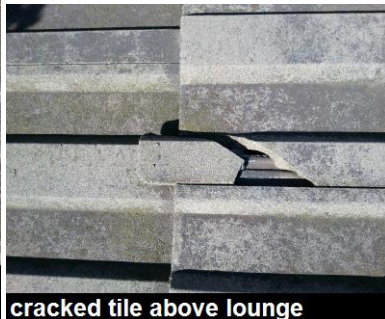
cracked tile above lounge

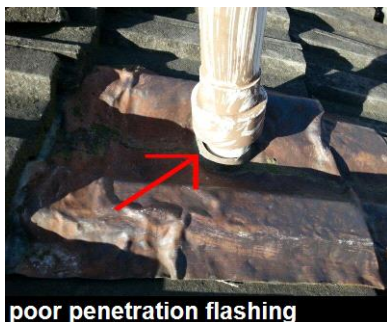
The potential for water entry is present. This should be fully investigated and a licensed roof plumber should be called to make a further evaluation and repairs or rectification as needed.

poor penetration flashing

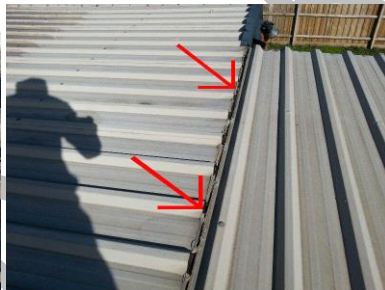
no capping above pergola/carport

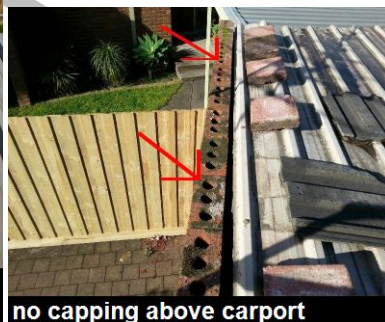
no capping above carport

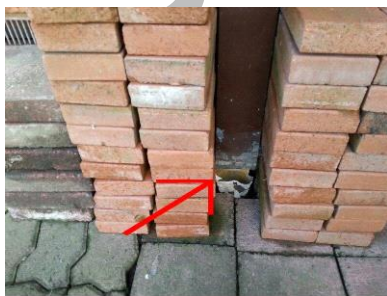
repair damaged downpipe (rear)

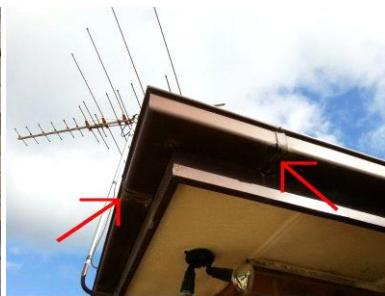
gutter joints leaking example

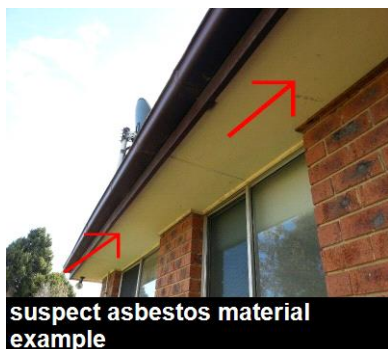
The eaves may be lined with asbestos cement sheeting. Although we are not qualified in the detection of asbestos material, the material found may contain asbestos. Asbestos material should be removed by a suitably qualified removal contractor if required.

suspect asbestos material example

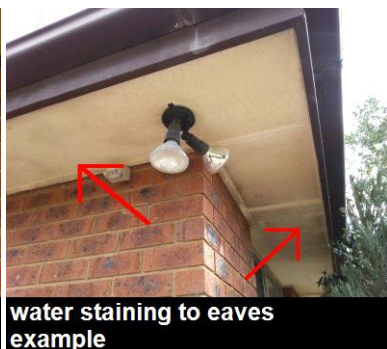
Water damage/staining is present to the eaves linings to the front elevation which may be due to a current or prior blocked gutter / downpipe, causing gutter overflow or a leaking roof or some other factor not visible on the day. This should be further evaluated by a roofing contractor.

water staining to eaves example

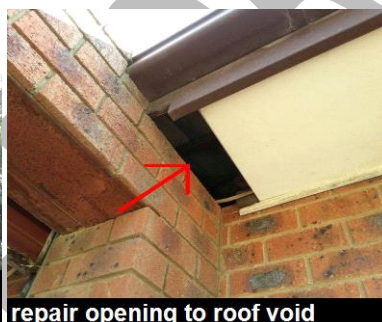
repair opening to roof void

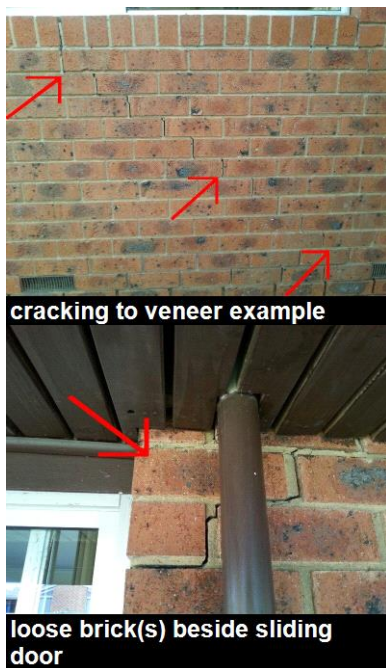
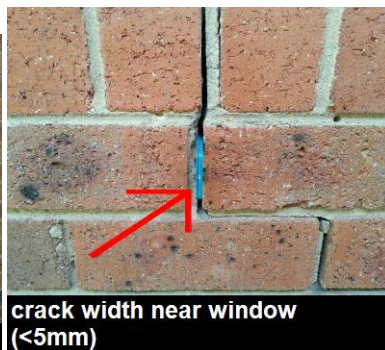
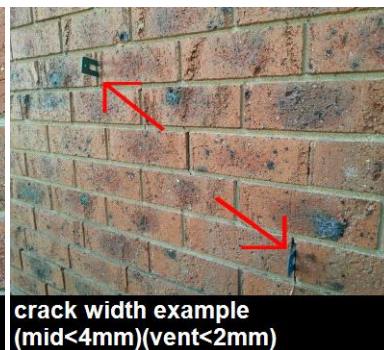
Minor cracks (<5mm) are evident to the mortar course outside the kitchen area, however, no evidence of major structural defects are visible from within the dwelling. Visible cracking has been categorised as a minor structural defect that may be a result of minor differential settlement to this area. Cracking of a building element is a structural defect where in the opinion of the inspector the function of the building element is impaired, or where the cracking is the result of the structural behaviour of the building. The expected consequence of this cracking is unknown until further information / monitoring is obtained. Please refer to section 9 in the Important Information section at the rear of this report for more information.

Cracking can be expected in a building of this age and construction type and fall into a slight cracking category and should be monitored for a period of 12 months, however we do recommend a structural engineer be contacted to comment further on these issues if cracking continues to increase dramatically during this period.

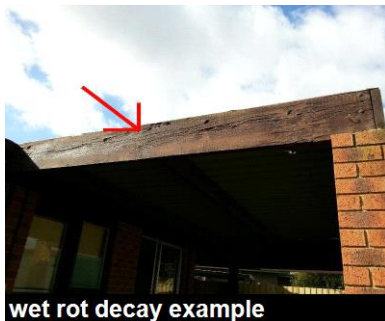
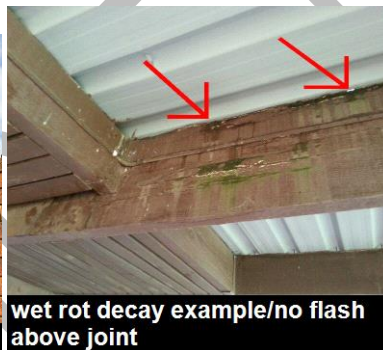
Moderate wood decay is present to the structure. Some repairs or maintenance will be required. A licensed carpenter and/or landscaper should be called to make a further evaluation and repairs or rectification as needed.

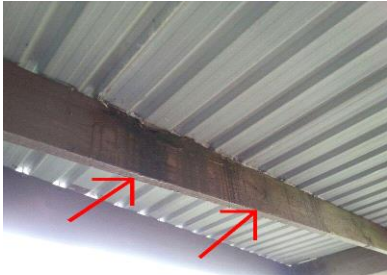
The flashing(s) are missing or in poor condition and requires repair or replacement. Metal deck and polycarbonate roof sheets have been end lapped, lapped incorrectly and siliconed together which is not considered good practice and is allowing water to penetrate causing wet rot decay to timber beams. The pitch of the roof section appears to be inadequate and is allowing wind driven rain penetration or water ponding and remedial action is required. Also, no guttering provisions are installed to the carport/ pergola roof areas..

water ponding above & leak decay to beam

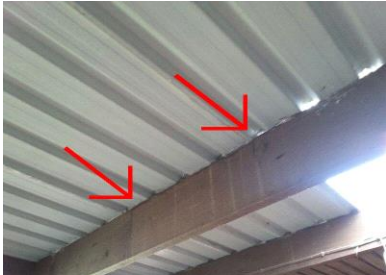
water ponding above & leak decay to beam

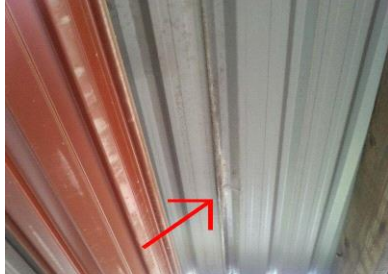
active leak from ponding water

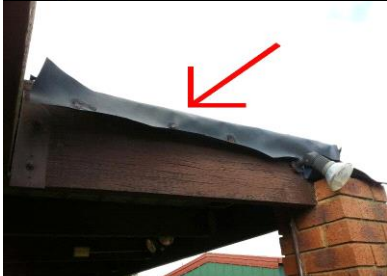
flashing inadequate ??

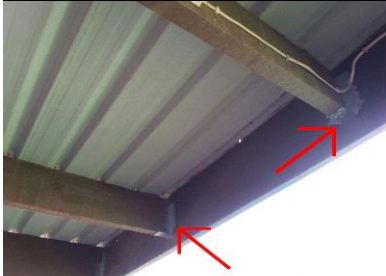
new joist hangers installed

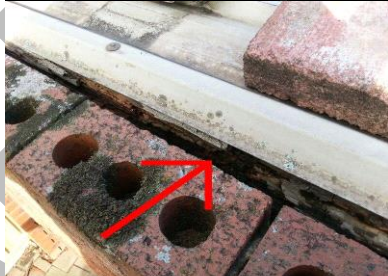
severe decay to roof timbers

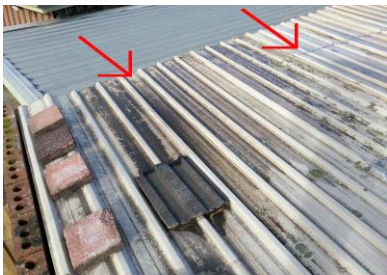
water ponding/no fall & gutter

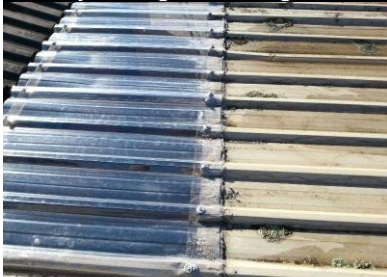
poor install example

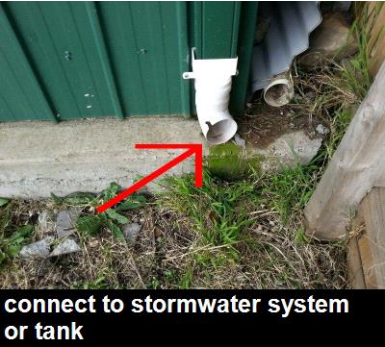
The downpipes do not appear to be connected to a stormwater dispersal system. This may or may not be a contributing factor to the poor drainage in this area. This should be rectified to prevent decay to surrounding components. This also effects the timber pest management of the property. A licensed roof plumber should be called to make a further evaluation and repairs or rectification as needed.

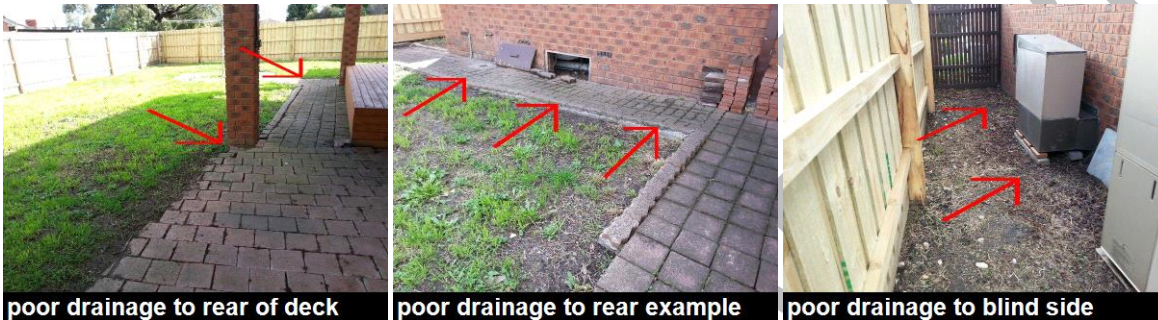
The drainage at the rear and right sides of the property appears inadequate. As a result, evidence suggests that surface water has been ponding and/or being directed toward the footings. Poor site drainage can create unstable foundations that may have an adverse structural effect over time and may produce conditions conducive to termite attack. Rectification is required and drains should be installed and ground/paths graded to divert seepage and surface runoff water away from the house. The drains should be connected to the existing stormwater drainage system. Please contact a licensed drainer or builder for further information.

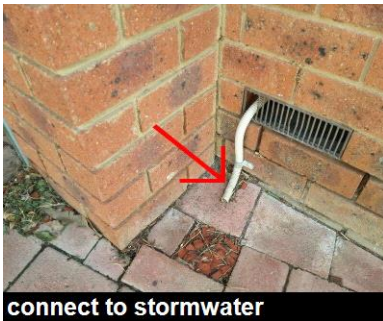
Air-conditioning is installed in the premises but has not been inspected, however, the pipe insulation will require minor repairs and condensation overflow pipes do not appear to be connected to the stormwater system. This may effect the timber pest management of the property. We recommend the pipe be connected to the stormwater system by a licensed plumber.

connect to stormwater

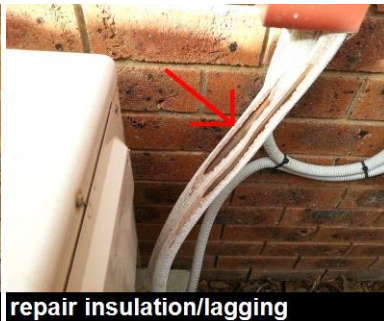
repair insulation/lagging

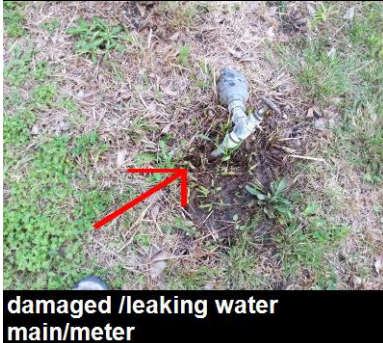
Impact damage and active water leaking is evident to the water meter and will require the attention of a licensed plumber.

damaged /leaking water main/meter

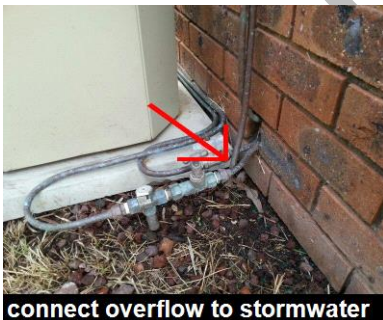
The hot water over flow pipe does not appear to be connected to the storm water system. This may effect the timber pest management of the property. We recommend the overflow be connected to the stormwater system by a licensed plumber.

connect overflow to stormwater
