Northern House Inspections

Report: 2596 - Sample

Building Inspection Report

**38 Sample Street
Sample Town, VIC 3000**

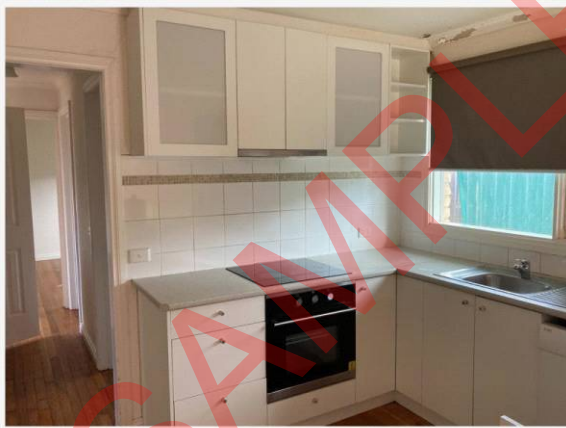
kitchen cabinetry is in good condition

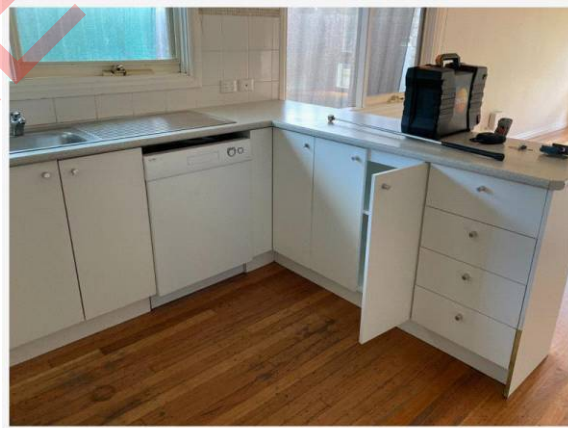
kitchen cabinetry is in good condition

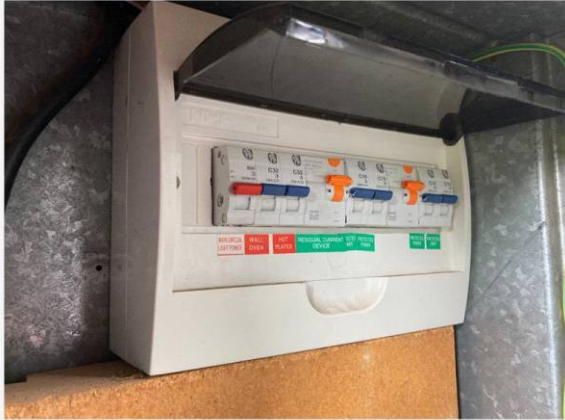
circuits appear OK | RCDs fitted

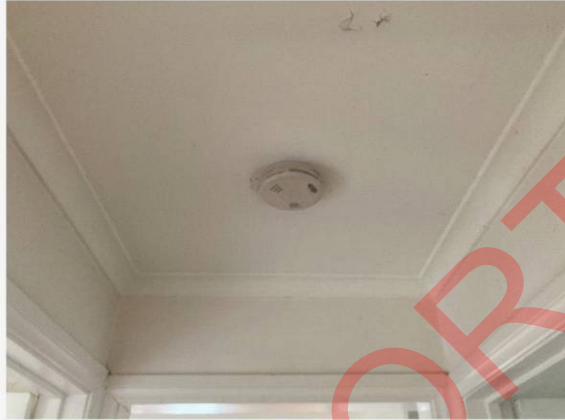
smoke detector fitted example

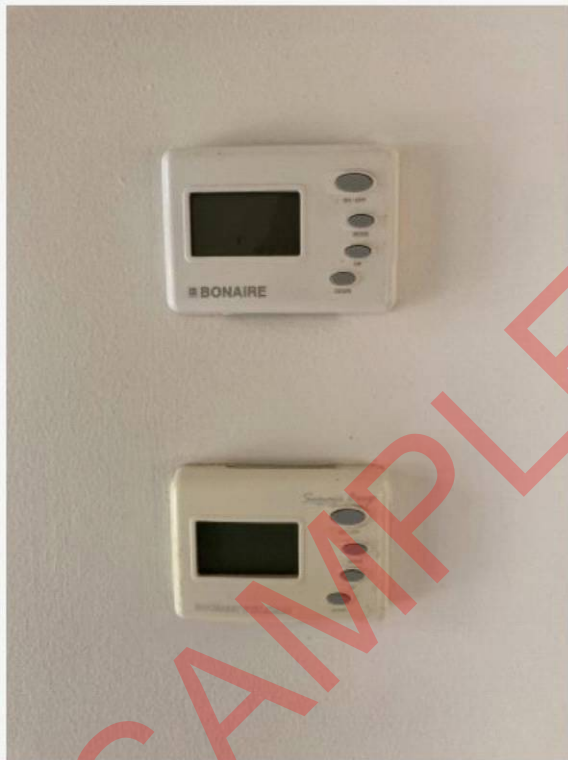
heating & cooling not tested on the day
