Northern House Inspections

Report: 2596 - Sample

Building Inspection Report

**38 Sample Street
Sample Town, VIC 3000**

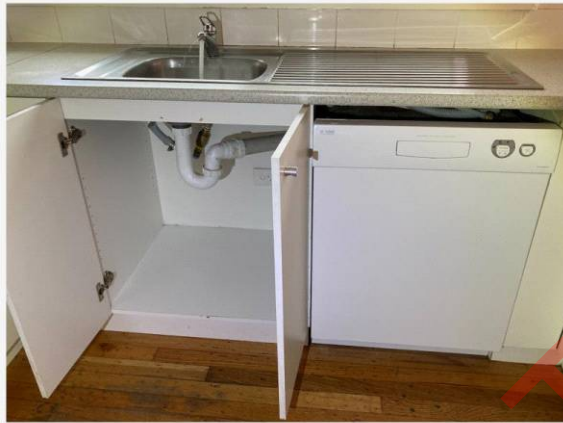
The condition of the cabinetry fixtures and appliances is generally good. However, the under bench oven is loose / not secured to the surrounding cabinet. We recommend additional screw fixings through the flange to the face of the cabinet. The installed dishwasher is not connected. A licensed plumber should be called to make further evaluation and repairs as needed.

D/W not connected

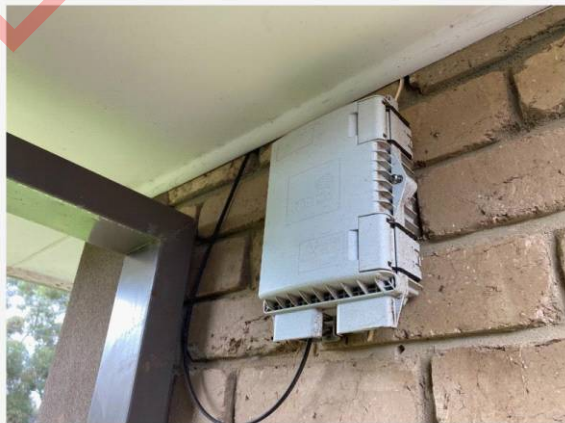
NBN is connected to the property
