Northern House Inspections

Pre Purchase Inspection Report

8 *****

Epping, VIC 3076

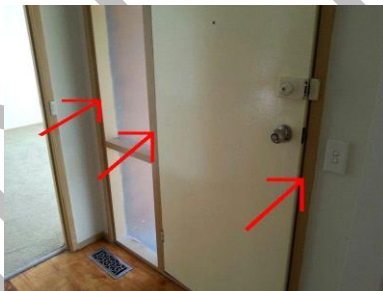
new frame/jamb timbers
installed

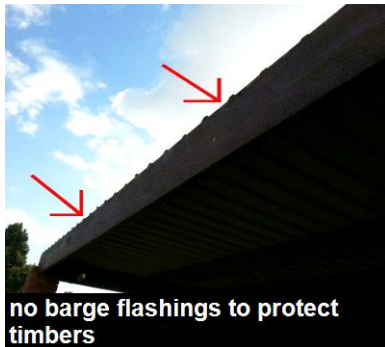
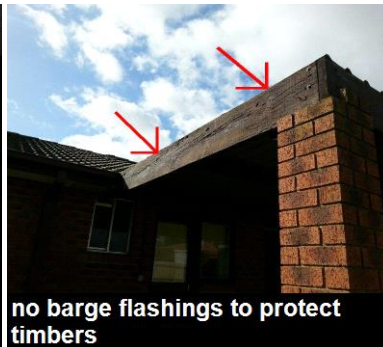
The overall condition of the roof coverings is fair.

Moderate wood decay is present to the structure. Some repairs or maintenance will be required. A licensed carpenter and/or landscaper should be called to make a further evaluation and repairs or rectification as needed.

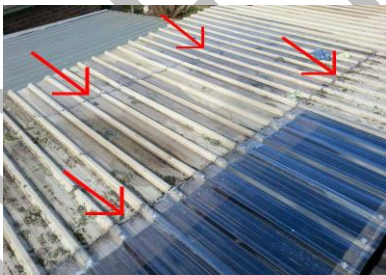
lapping of roof sheeting ??

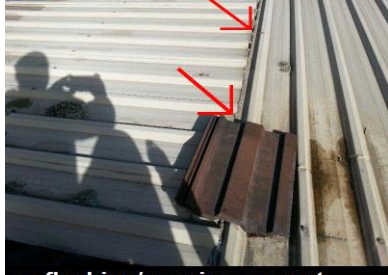
no flashing/capping carport-pergola

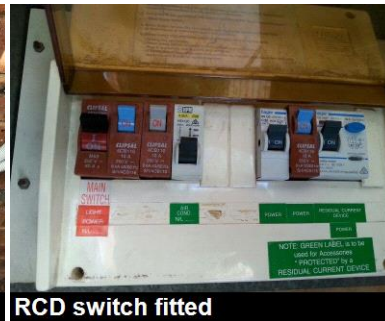
RCD switch fitted
